**SEDIMENTATION CONCERNS ASSOCIATED WITH THE PROPOSED  
RESTORATION OF HERRING RIVER MARSH, WELLFLEET,  
MASSACHUSETTS**

Prepared for Cape Cod National Seashore, The Town of Wellfleet and The Association  
for Women Geoscientists, as part of a Geologist in-the-park project performed during the  
fall-winter of 2003-2004

*By: Amy J. Dougherty*

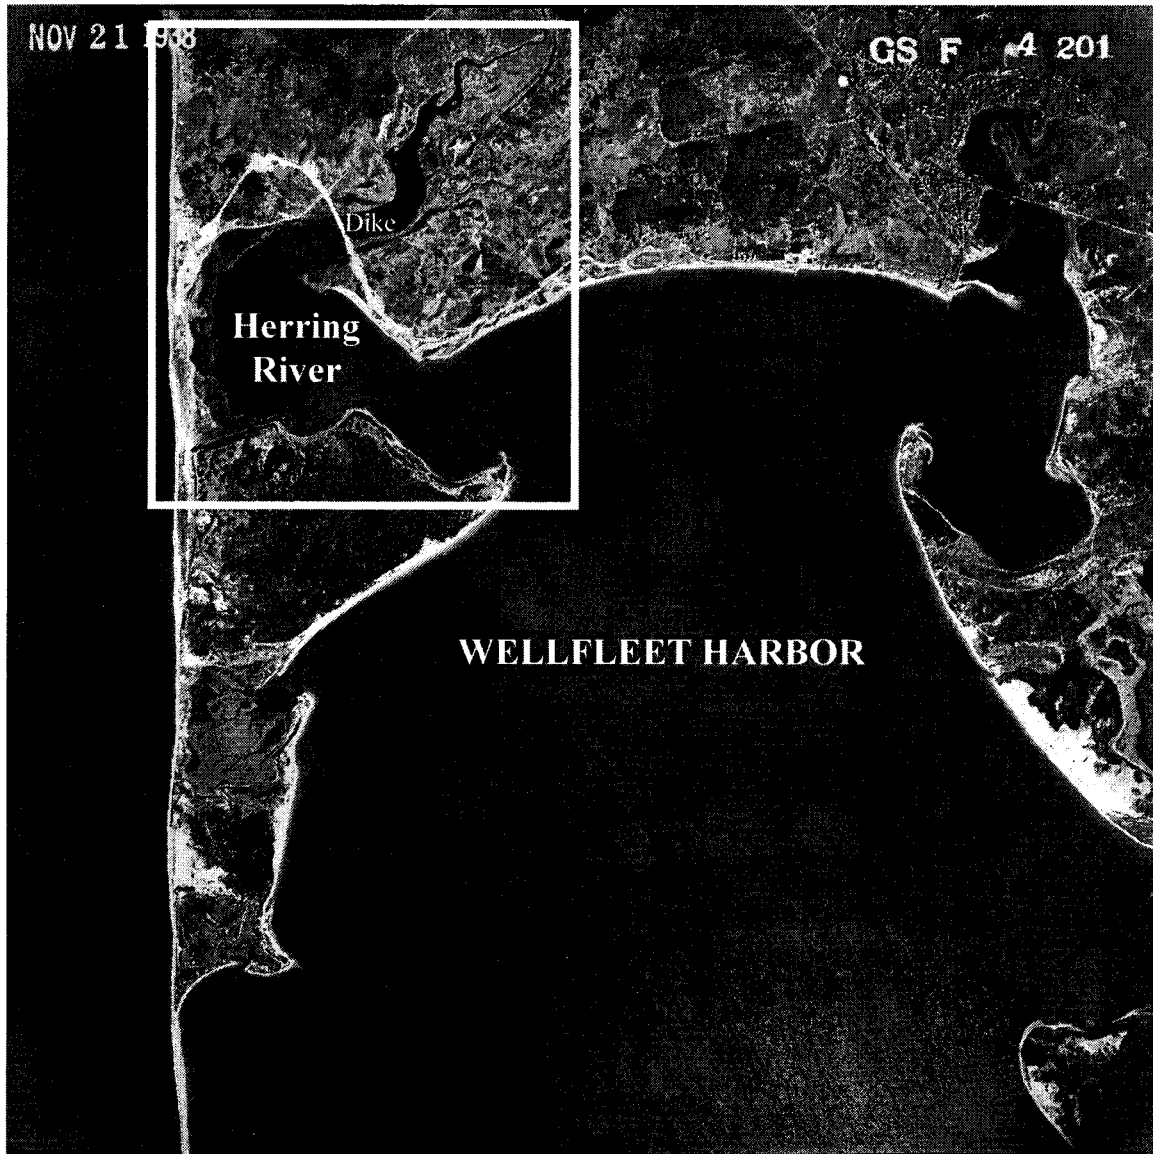
**Figure 1.2: Location of Herring River with respect to the Wellfleet Harbor.**

Since 1909 the Herring River in Wellfleet, Massachusetts has been tidally restricted by a dike (Figure 1.1 & 1.2). The original 100-meter-wide channel is blocked by a causeway (Figure 1.2), with the exception of three two-meter-wide box culverts in the middle. The southern culvert is fitted with an adjustable sluice gate, whereas the other two contain flapper gates that allow flow only in a seaward direction. The purpose of diking (Figure 1.3), and subsequent draining (Figure 1.4), of this salt marsh system was to facilitate mosquito control and to provide additional land for development. Other than the extension of Chequesset Neck Road, the construction of two dwellings and a portion of a golf course within the river valley, no other land has been developed and mosquitoes remain a problem (Soukup and Portnoy, 1986).

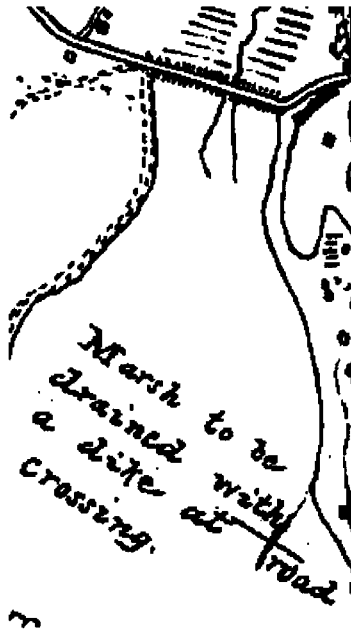
**Figure 1.4: 1909 T-sheet indicating that the marsh above the Herring River Dike is to be drained.**

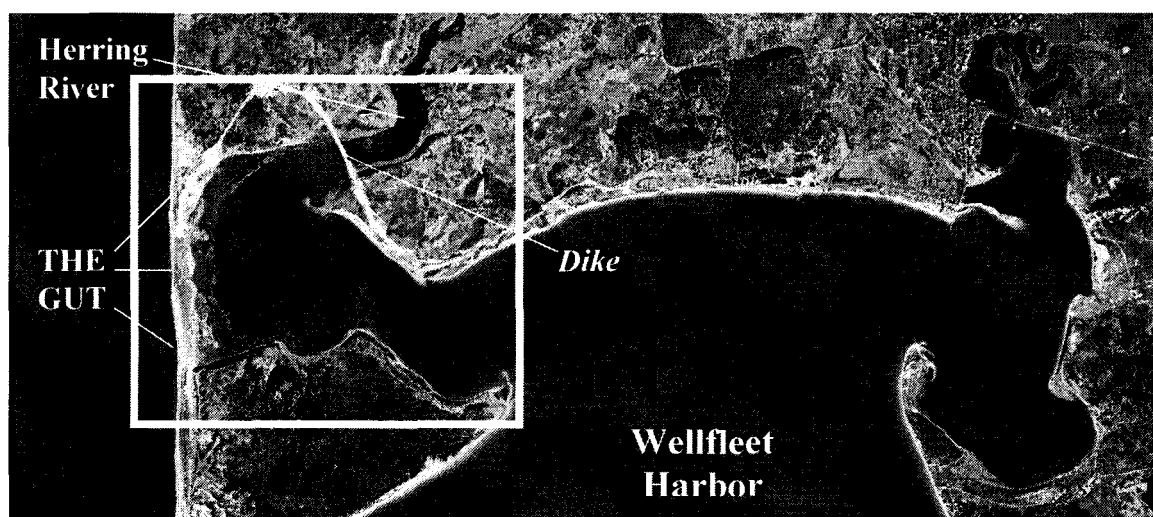
**Figure 2.1: Location of The Gut in relation to the Herring River & Wellfleet Harbor**

People frequently ask whether opening the Herring River Dike would threaten the stability of The Gut or cause it to breach. This is of great concern because this strip of land channels the Herring River outflow into Wellfleet Harbor rather than directly into Cape Cod Bay (Figure 2.1). It is commonly thought that a breach might threaten shellfish resources in and around Wellfleet Harbor from an influx of bay water changing salinity, temperature and nutrients within the shellfish-rich inner basin.

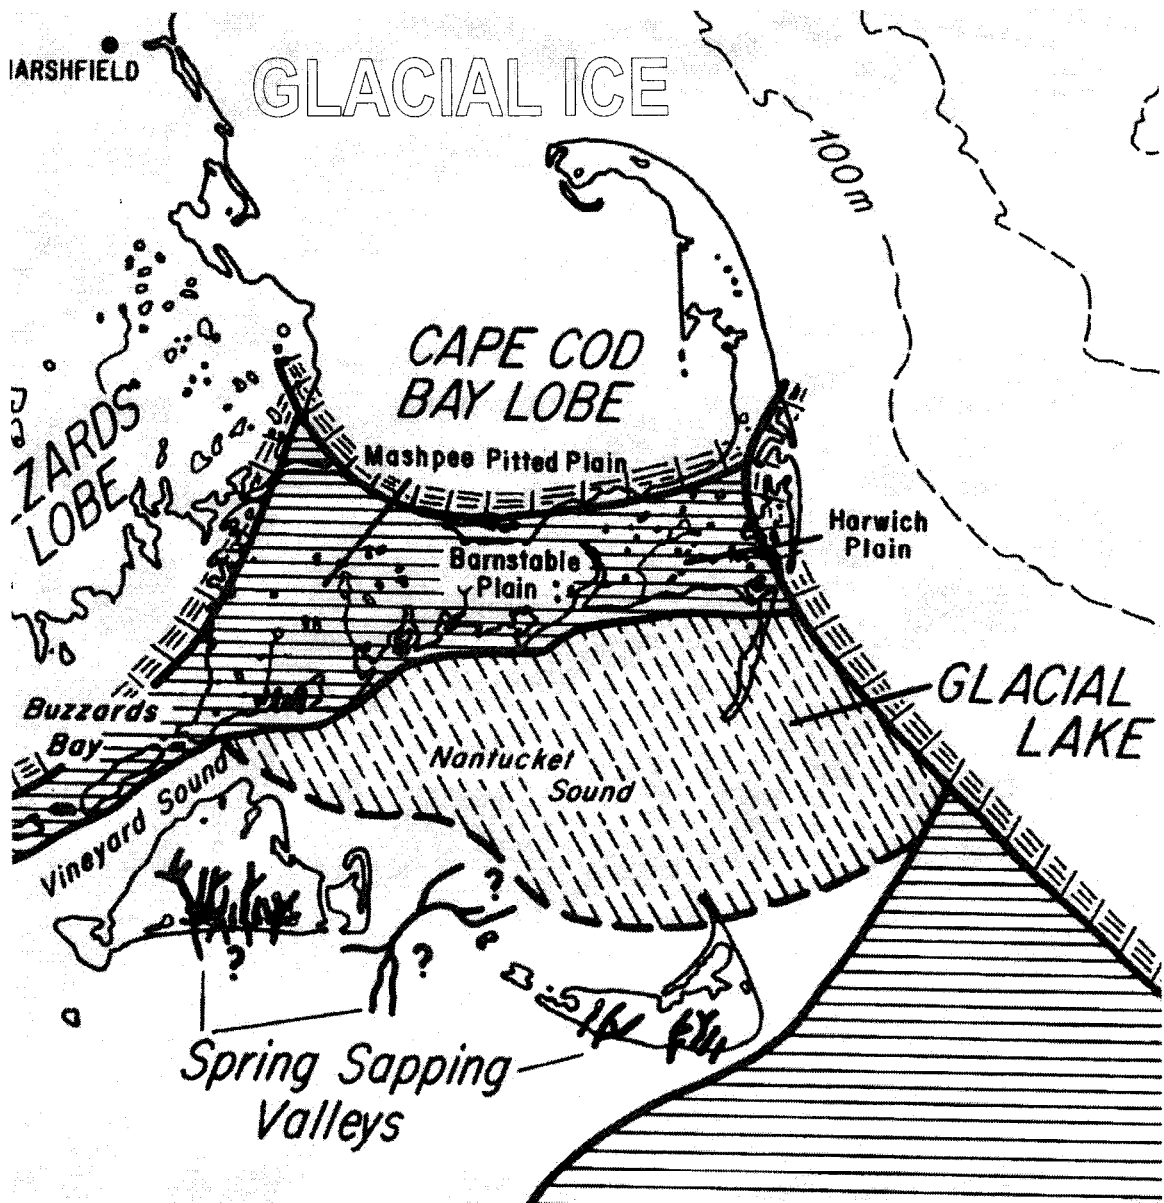
Figure 2.2: Map of southeastern Massachusetts as it looked prior to 18,000 years ago. Note the position of the ice lobe that occupied present-day Cape Cod Bay. (Uchupi et al., 1996)

Wellfleet Harbor occupies a part of a large depression that formed due to the existence of the glacial ice that prevented the deposition of outwash sands (Figure 2.2). As the ice melted and sea level rose the depression filled with water forming Cape Cod Bay. Islands such as Griffin Island, Great Island and Great Beach Hill formed from sands that filled holes or depressions in the ice; as ice melted and sea level rose, they became surrounded by water. Despite their names, one would not consider these features to be islands today due to their connections to each other and the mainland (Figure 2.4). However, in the 1720s many people lived on these islands, which protected deep and useful anchorages at the time (Wood, 1973). A sketched map of the Cape by Henry David Thoreau depicts these islands as such, isolated by water (Figure 2.5).

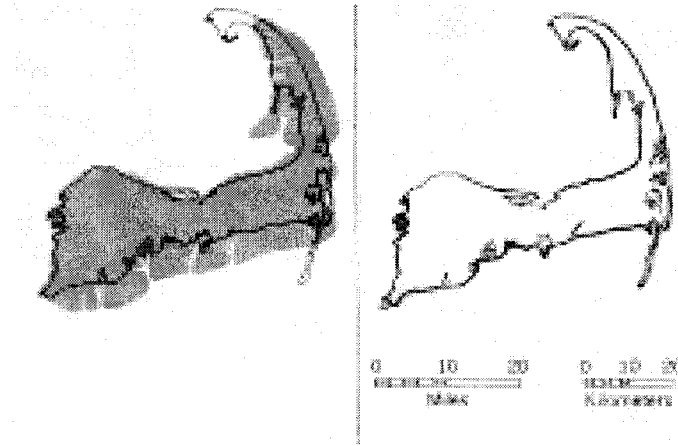
**Figure 2.3: On the left in green/gray is the hypothetical configuration of the Cape about 6,000 years ago, before extensive wave erosion of these glacial deposits formed the current shape outlined in black. The right is a map showing the present pattern of erosion, with red (black) indicating shorelines experiencing erosion and green (gray) displaying areas undergoing deposition. (Odale, 2001)**

As glaciers move they scour the land underneath them and accumulate sediment within the ice. When a glacier stops and begins to retreat it leaves behind a large deposit of sediment, known as a moraine. The northern portions of Martha's Vineyard, Nantucket and Long Island are all moraines, known as terminal moraines, because they mark the southernmost extent of ice in the northeast region. As the ice retreated during the last glacial period, it either readvanced and/or stagnated just north of its farthest extent (Figure 2.2) forming a recessional moraine and outwash plains that now comprise Cape Cod (Figure 2.3). Further retreat and melting of this continental ice sheet returned water to the ocean basins causing global sea level to rise. Eventually the rising sea encroached upon the glacial deposits left behind by the ice. Around 9,500 years ago, rising sea level reached exposed Cape and wave erosion of the glacial deposits began. At first, uplands composed of glacial drift began to erode as waves attacked the fragile land forming sea cliffs. The eroded sand was then transported and redeposited by waves and currents to form bays, like Pleasant Bay and Wellfleet Harbor, protected from the open ocean by barrier spits and islands (Figure 2.3) (Uchupi et al., 1996).

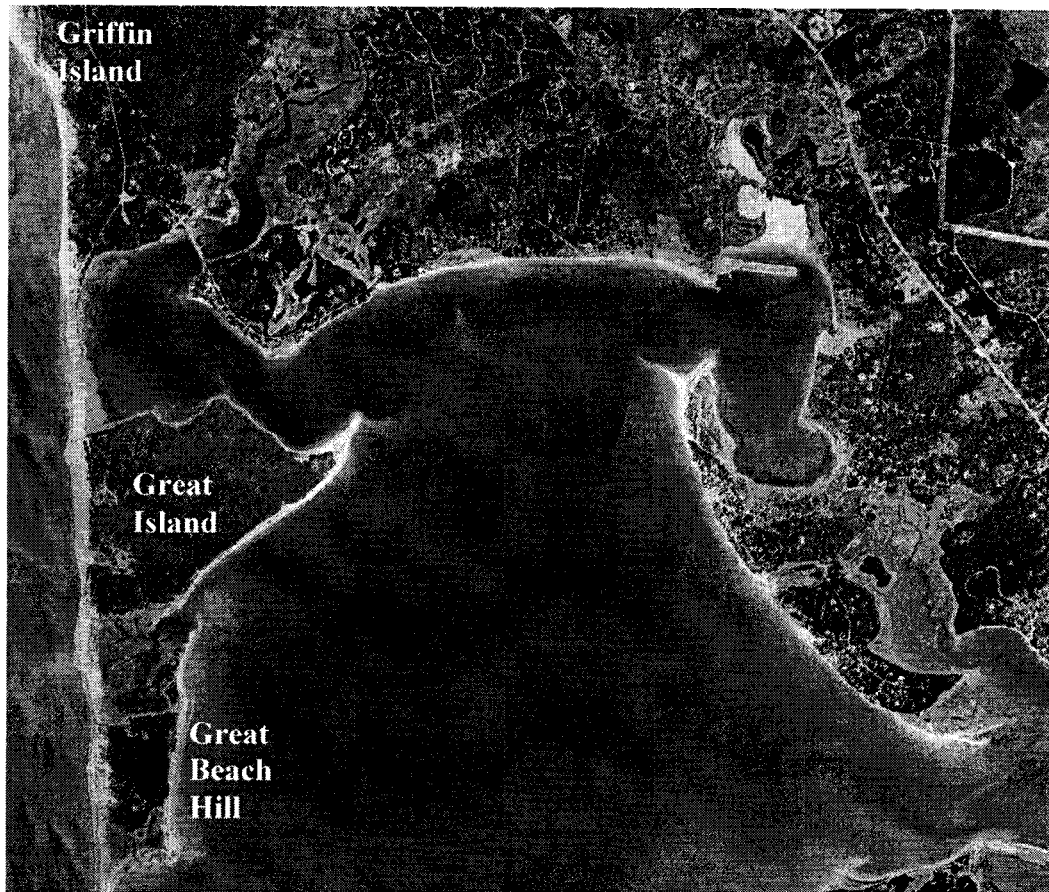
**Figure 2.4: This 2001 air photo of Wellfleet Harbor shows the present day connected nature of the Wellfleet Harbor Islands.**

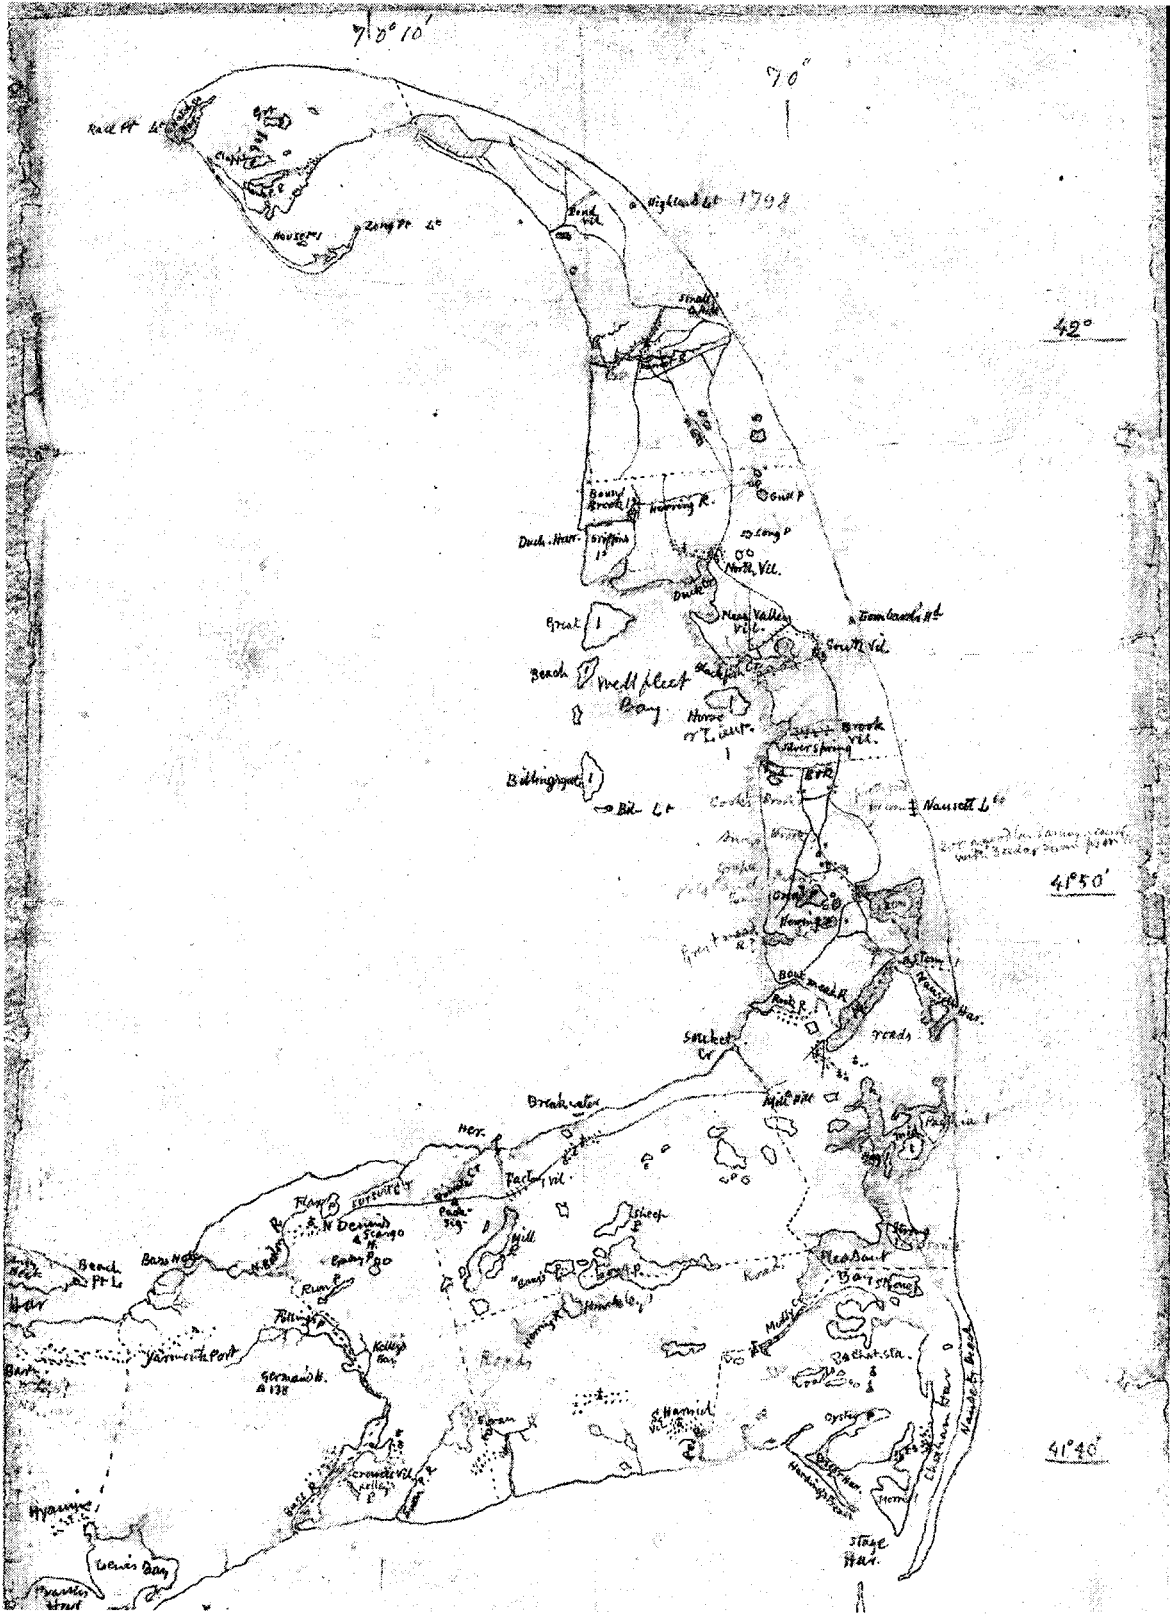
**Figure 2.5: This map is a portion of a sketch of the Cape drawn by Henry David Thoreau. Note the depiction of the Wellfleet Harbor Islands as unattached.**

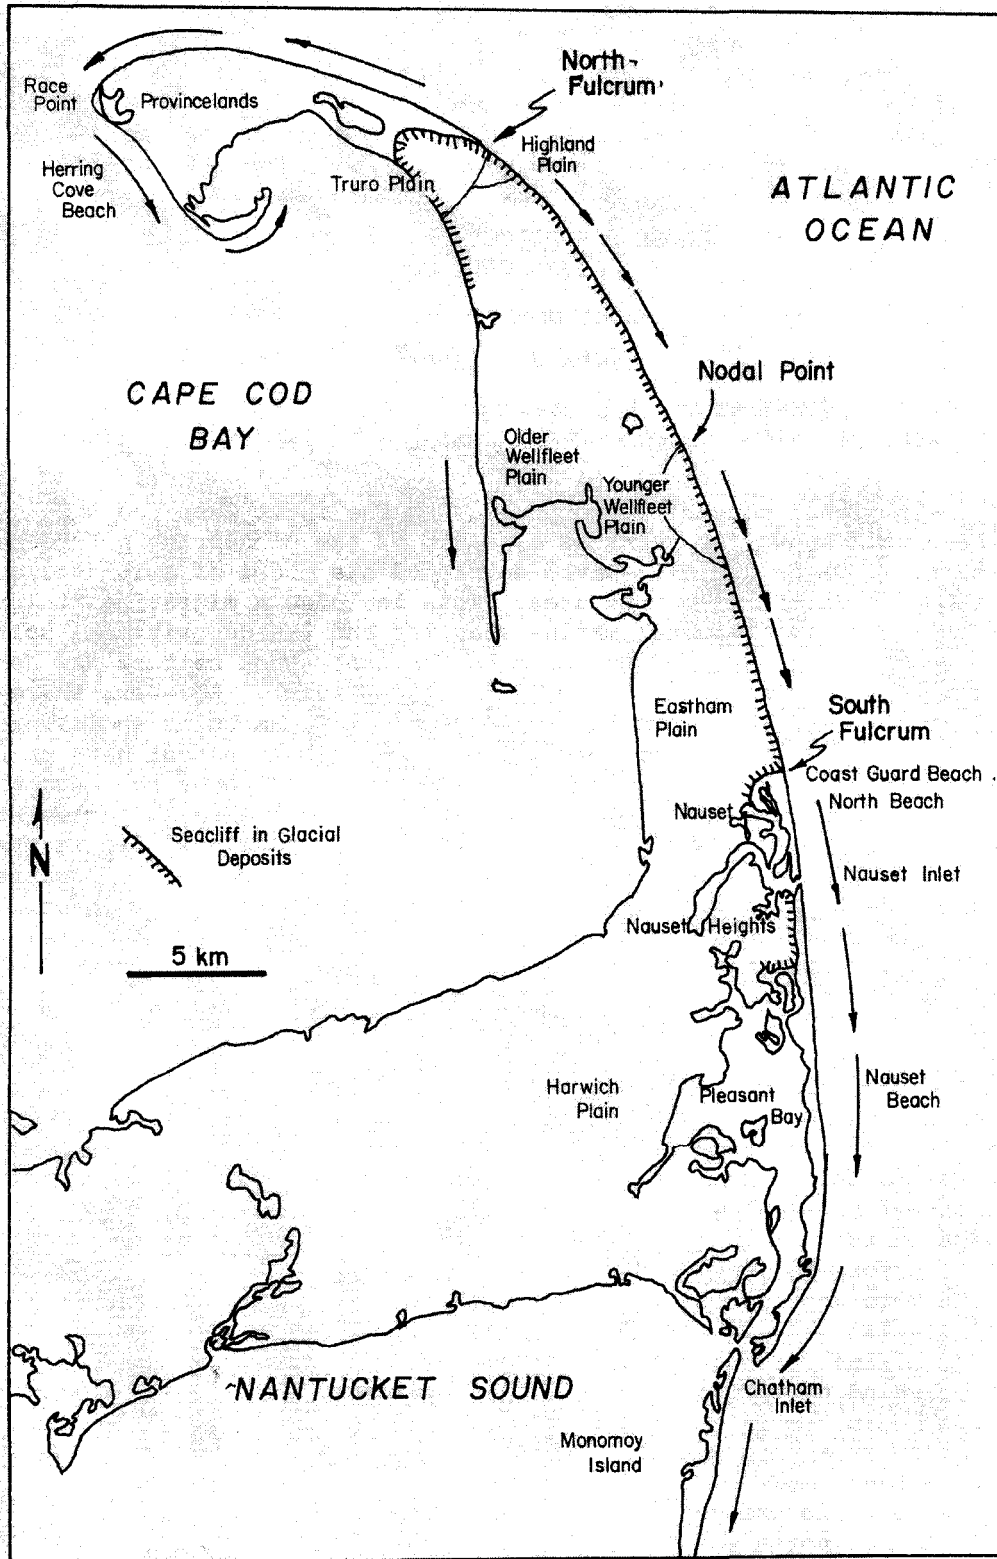
**Figure 2.6: Sediment transport map of outer Cape Cod showing the southward transport of sands eroded from the adjacent Wellfleet bay side beaches. (Fisher, 1979)**

On the ocean side of the outer Cape, continued sea-level rise and persistent erosion took sand from the glacial sea cliffs and transported it north (Figure 2.6) to form the Provincetown Spit (Figure 2.7). A spit is a peninsula-like accumulation of sand that extends off the mainland, sometimes curving at the end to form a recurved spit. The formation of the Provincelands prevented sediment transport to the Cape Cod bay beaches from the Atlantic (Figure 2.6). However, sediment from the eroding bay-side uplands continued to supply sand to the bay side beaches by long shore drift. The sand moving south formed a spit of land off of the Wellfleet mainland. Eventually this spit connected to the northernmost island and then each successive island to the south (Figure 2.8). This accumulation of sand that ties two landmasses together is known as a tombolo. Once these tombolos were in place, they provided protection from waves and formed the sheltered environment of Wellfleet Harbor. As a result of this quiet environment, marshes formed behind these tombolos (Figure 2.8). The newly formed marshes became so extensive north of The Gut that they actually filled in Duck Harbor landlocking Merrick Island (Figure 2.10).

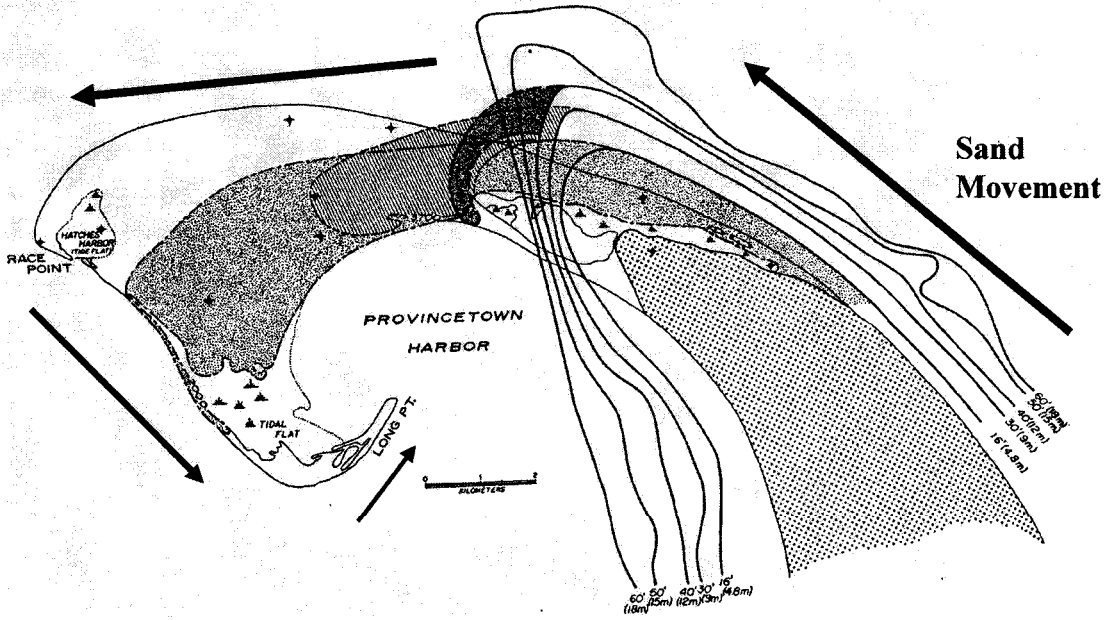
**Figure 2.7: Sediment transport map showing the evolution of the Provincetown Spit. Note that each successive black line from right to left is the former configuration of the Provincetown Spit. The spit was initially building to the northwest and then begins to recurve due west, southeast and then due east. This shape is a result of open-ocean waves interacting with Cape Cod Bay tidal forces. (Zeigler et al. 1965)**

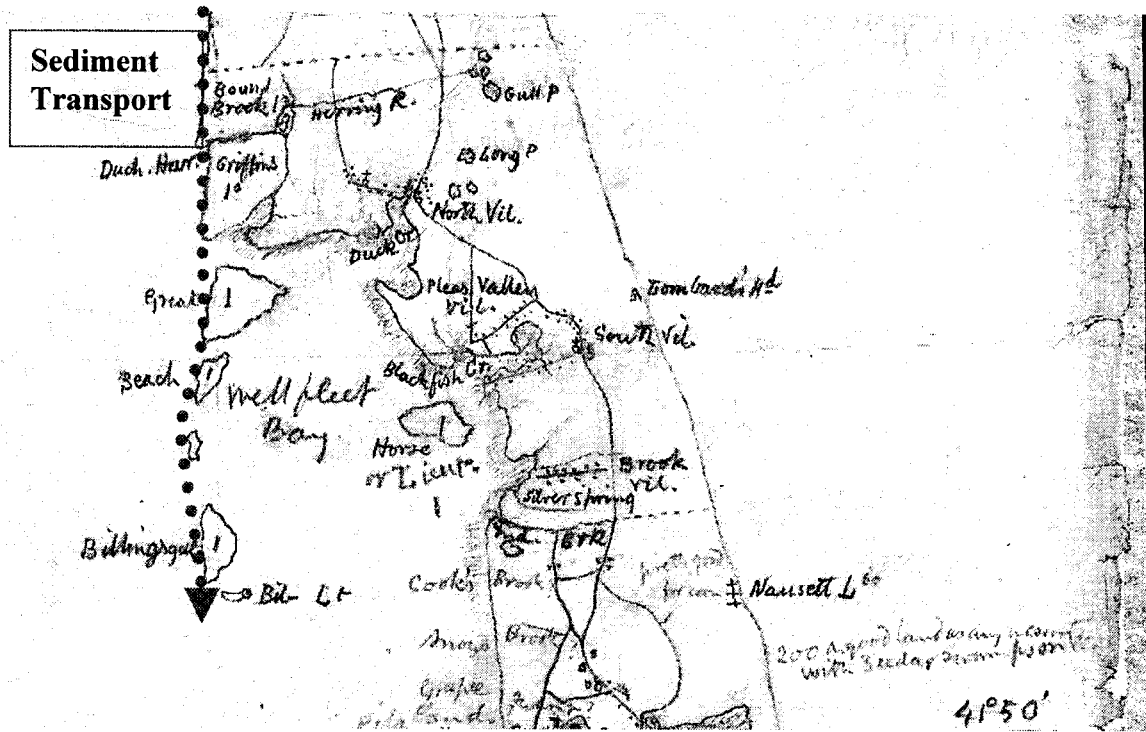
**Figure 2.8: Map of sediment transport superimposed on Thoreau's sketch showing the formation of tombolos that connect the islands.**

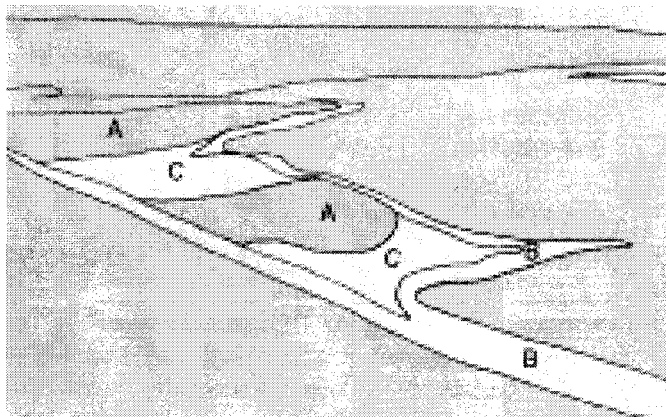
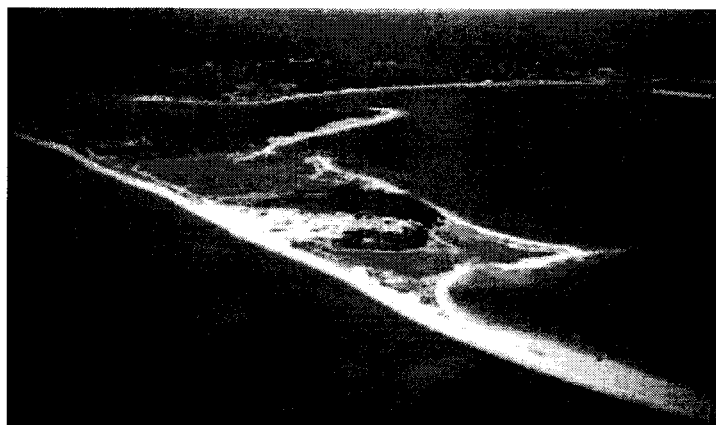
**Figure 2.9:** Top left is a cartoon schematic showing the evolution of the area directly south of The Gut, which is how it would have formed without the existence of the Herring River. First the islands are created by glacial deposits (A) then sand transported southward forms tombolos connecting them B) and as a result of the quiet water environment behind the spits and tombolos a thick marsh forms (C). The bottom right image is a photograph of the area illustrated above. (Oldale, 2001)

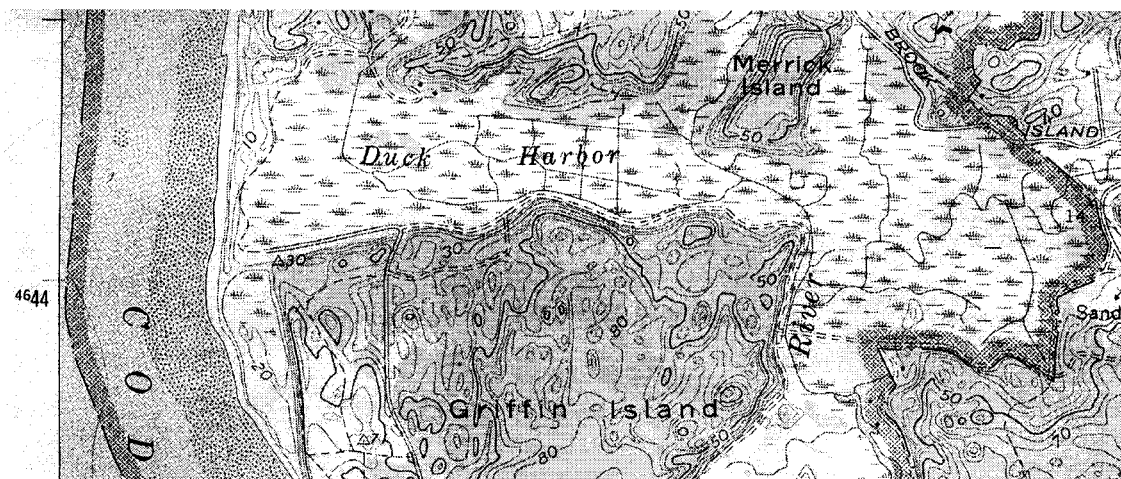
**Figure 2.10:** 1974 coastal chart showing the presence of marsh where Duck Harbor once existed.

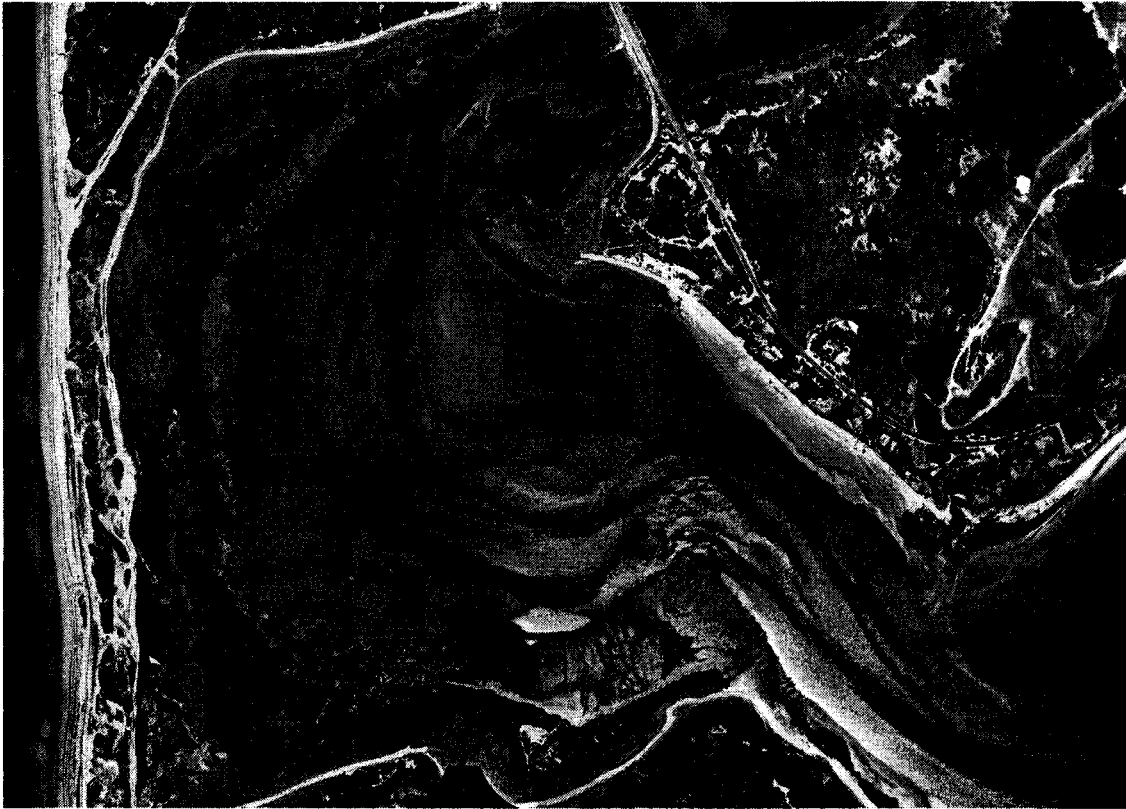
**Figure 2.11: Air photo taken at low tide reveals broad mudflats flanking either side of the main ebb channel of the Herring River. This shows that flow velocities are not strong enough to even scour the channel banks, much less breach The Gut.**

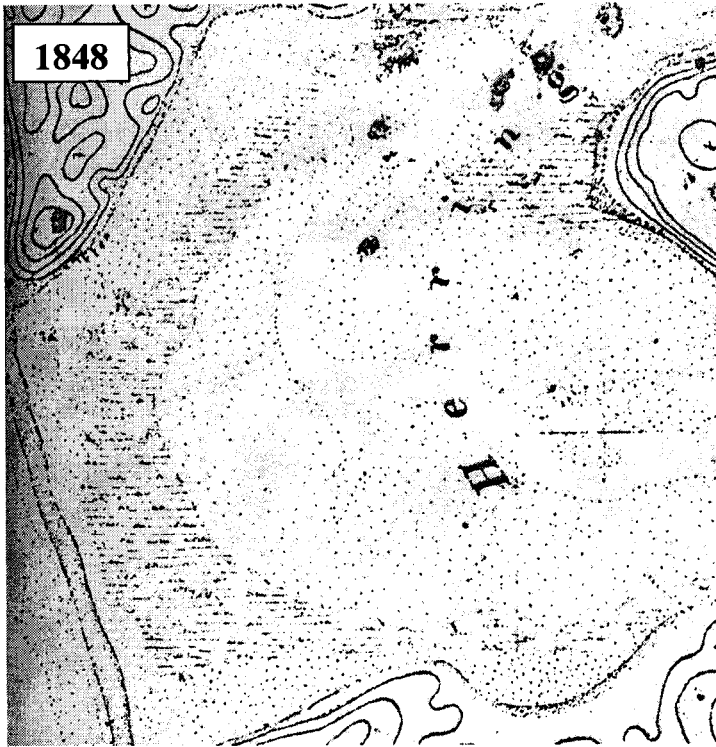
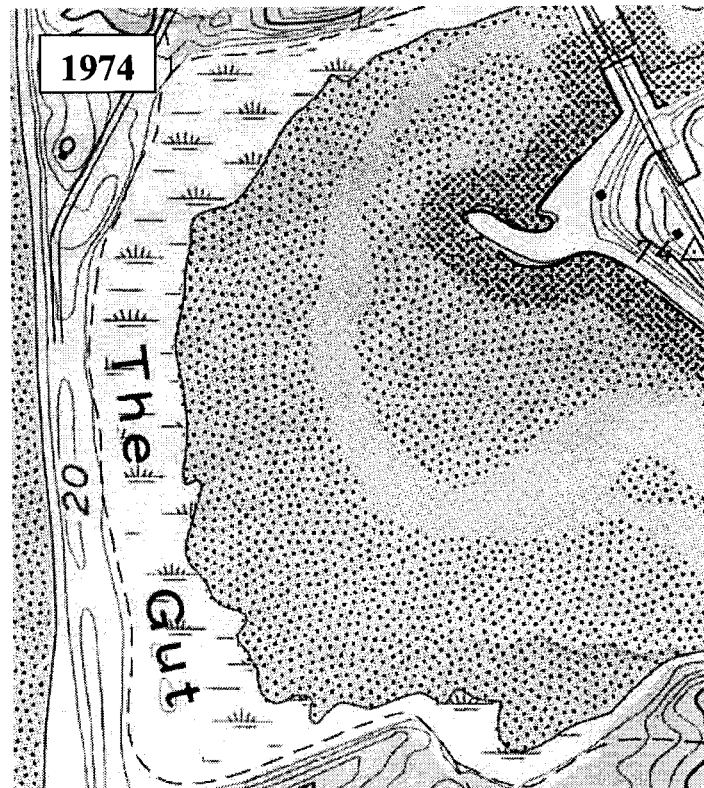
**Figure 2.12: Comparison of coastal charts from 1884 and 1974 show that the main ebb channel has not moved throughout the last 100 years and thus was the same prior to the construction of the dike in 1909. Therefore, the position of the ebb channel is not expected to change if the dike were opened.**

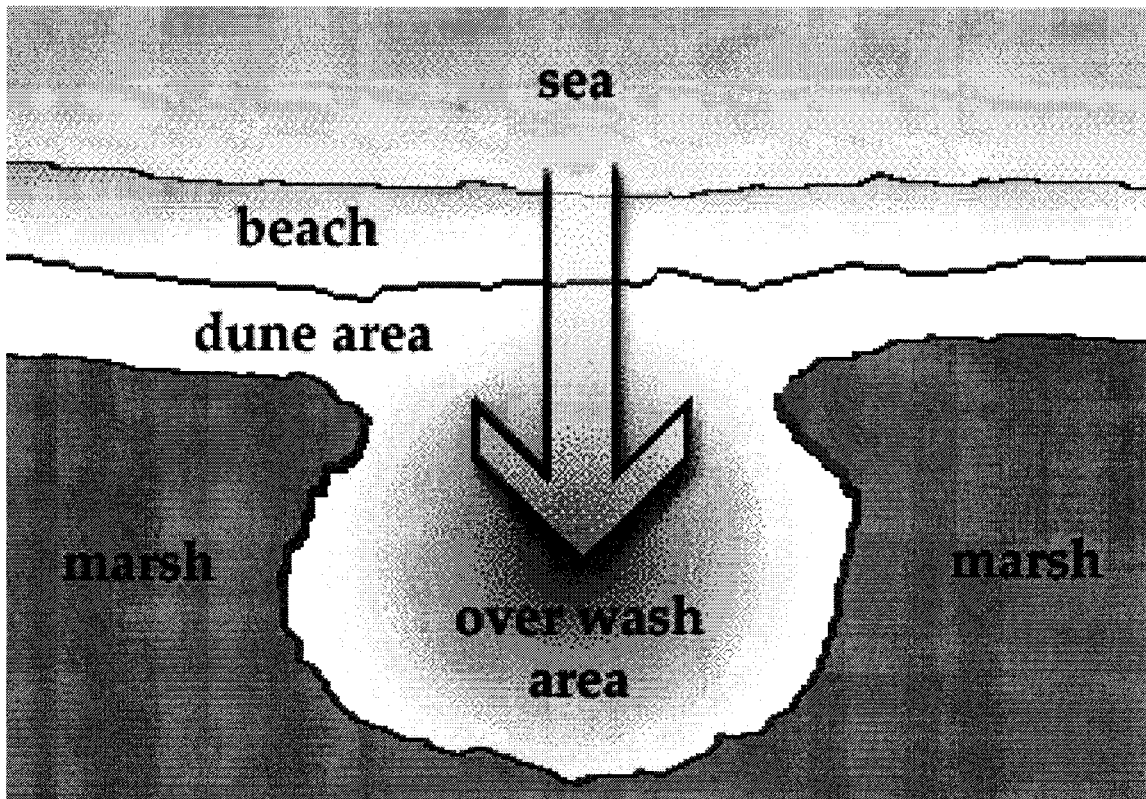
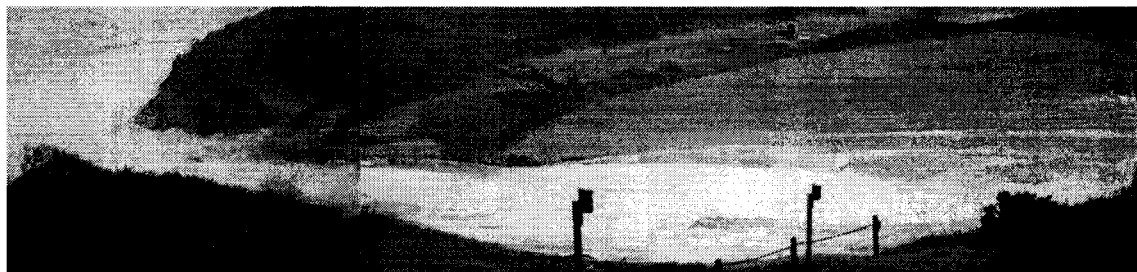
**Figure 2.13: Above is a cartoon showing the aerial view of a washover forming on a barrier. Below is a photo taken at Ballston Beach during an overwash in 1991. Even this large overwash on the highly dynamic Atlantic shore did not result in a permanent inlet.**

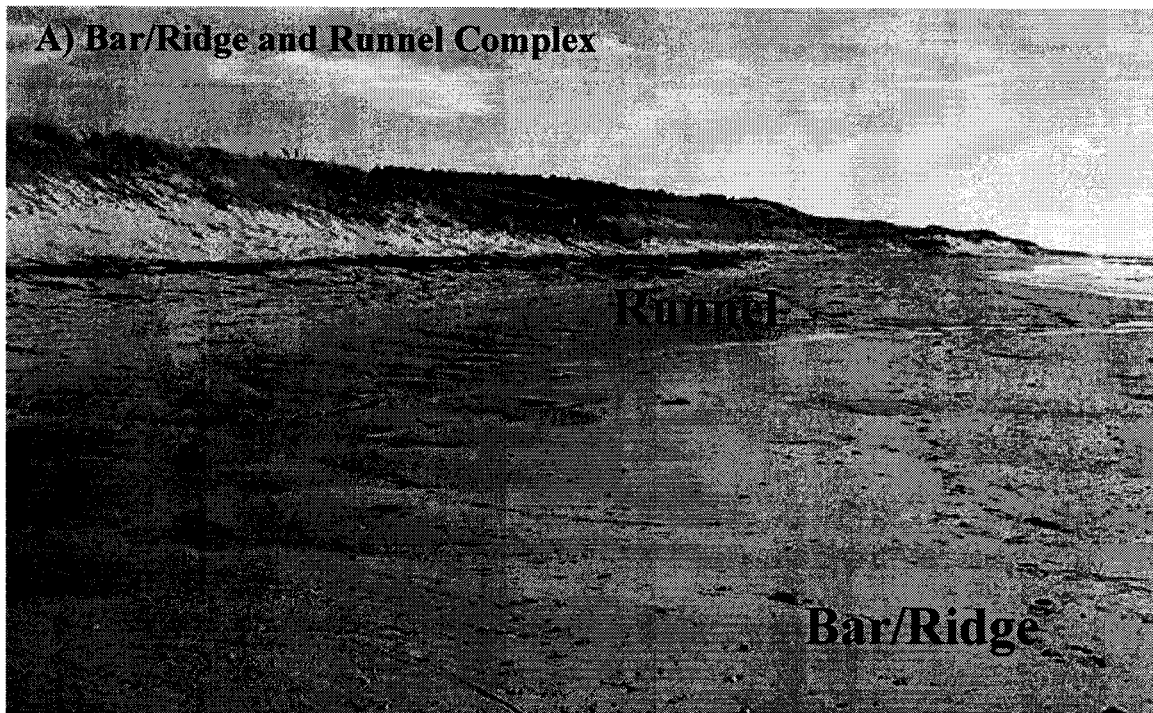
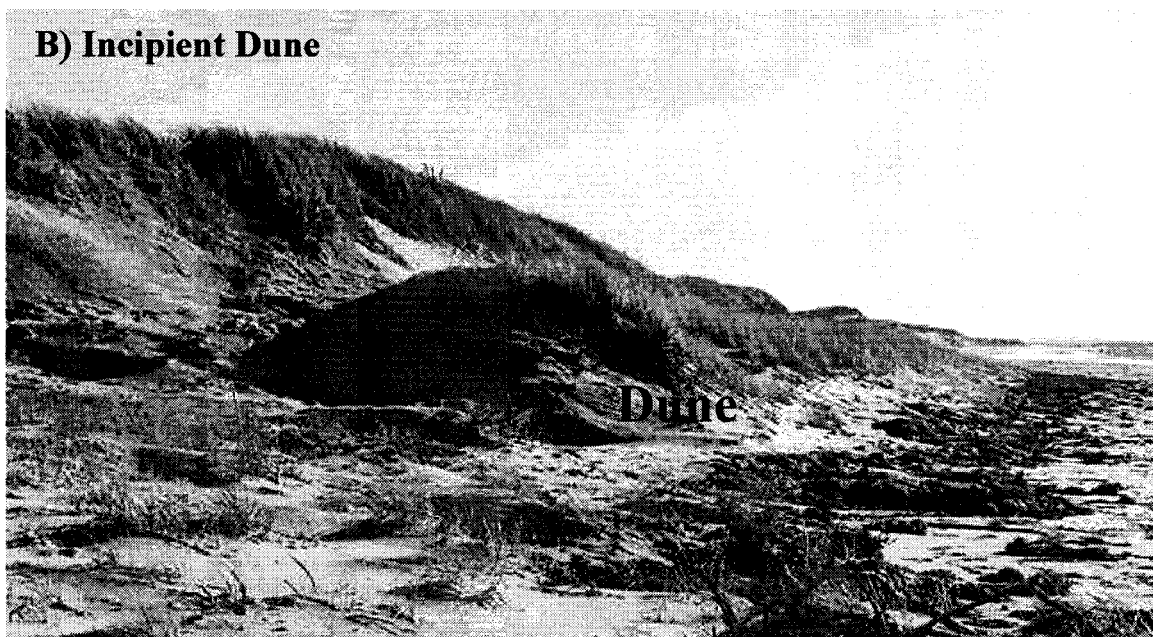
**Figure 2.14: Present day pictures along The Gut showing barrier recovery mechanisms that occur after a storm to rebuild the beach. A) Shows a bar or ridge of sand that is reworking back onshore after being eroded by waves from a high-energy storm event. The topographic low landward of the ridge is known as a runnel, where water tends to pool after a high tide. B) Is a picture of a new dune that is forming from fine-grained particles of sand that are moved by wind.**

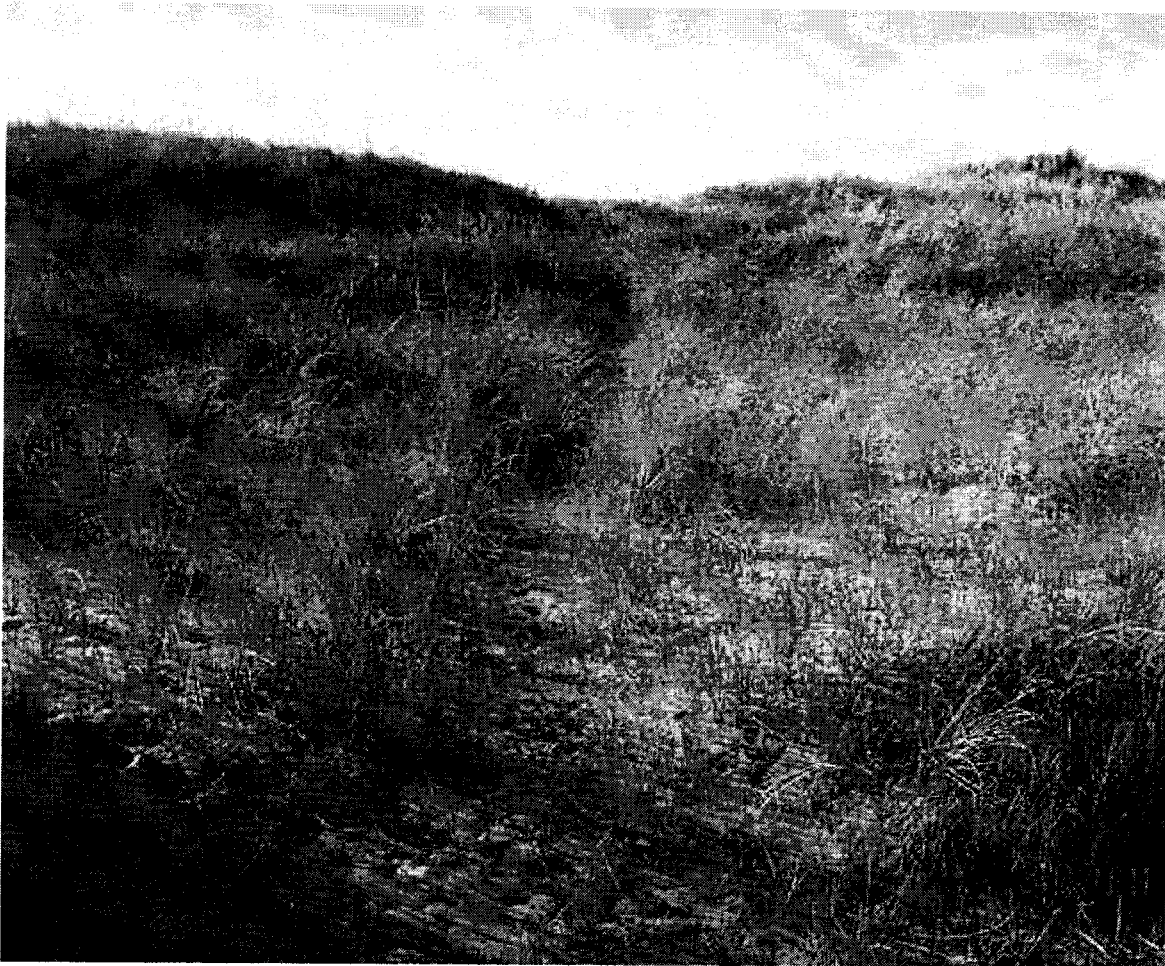
**Figure 2.15: Vegetation loss on the dune due to pedestrian traffic.**

Both sea-level rise and a deficit in the sand supplied to this system are the main natural forces of erosion along The Gut. However, anthropogenic factors such as pedestrian traffic are exacerbating this erosion. The mere act of walking over the dunes to gain beach access results in the trampling of vegetation that is vital in stabilizing the dune sand (Figure 2.15). Loss of vegetation remobilizes sand and, where a path may form from cross-dune traffic (Figure 2.16), the wind is focused and causes downward erosion (Figure 2.17). These low-lying devegetated areas are ideal sites for blowout formation (Figure 2.18) and subsequent washovers during storms.

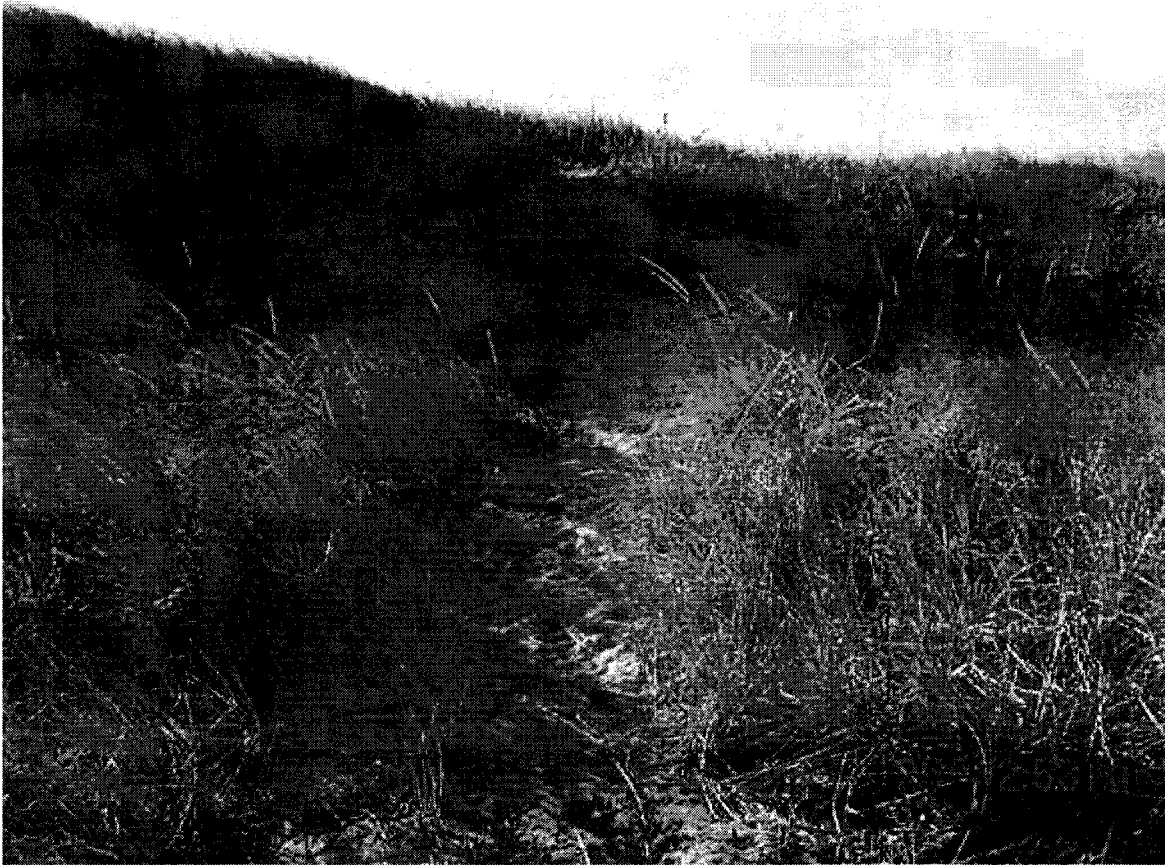
**Figure 2.16: Established path has caused complete elimination of vegetation.**

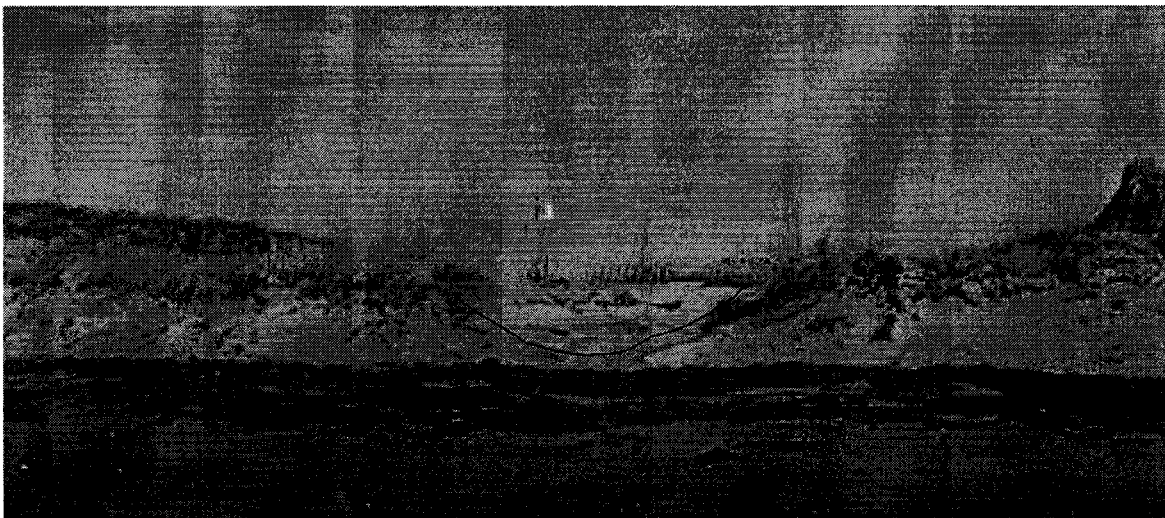
**Figure 2.17: Severe erosion, outlined in red (black), which can develop over an established path.**

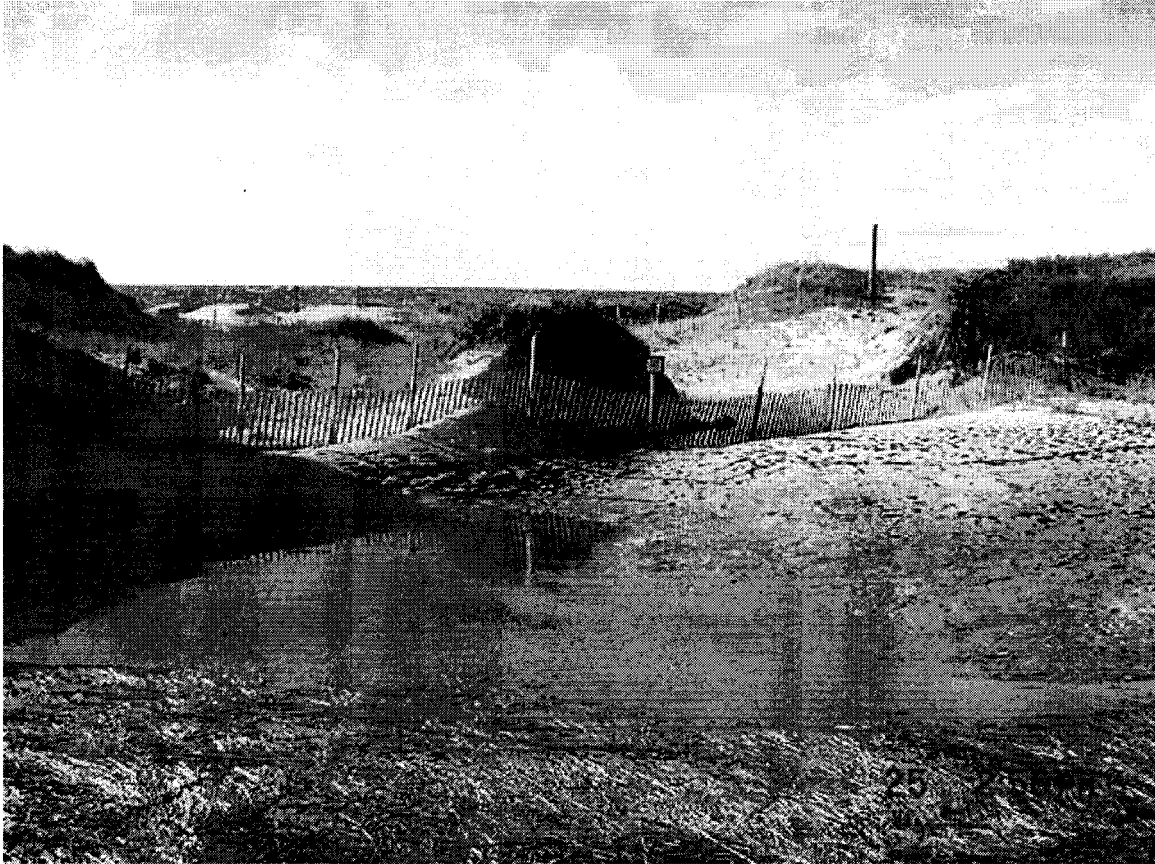
**Figure 2.18: Dune blowout on the southern end of The Gut. These blowouts form as wind is funneled through topographic lows between dunes as a result of erosion.**

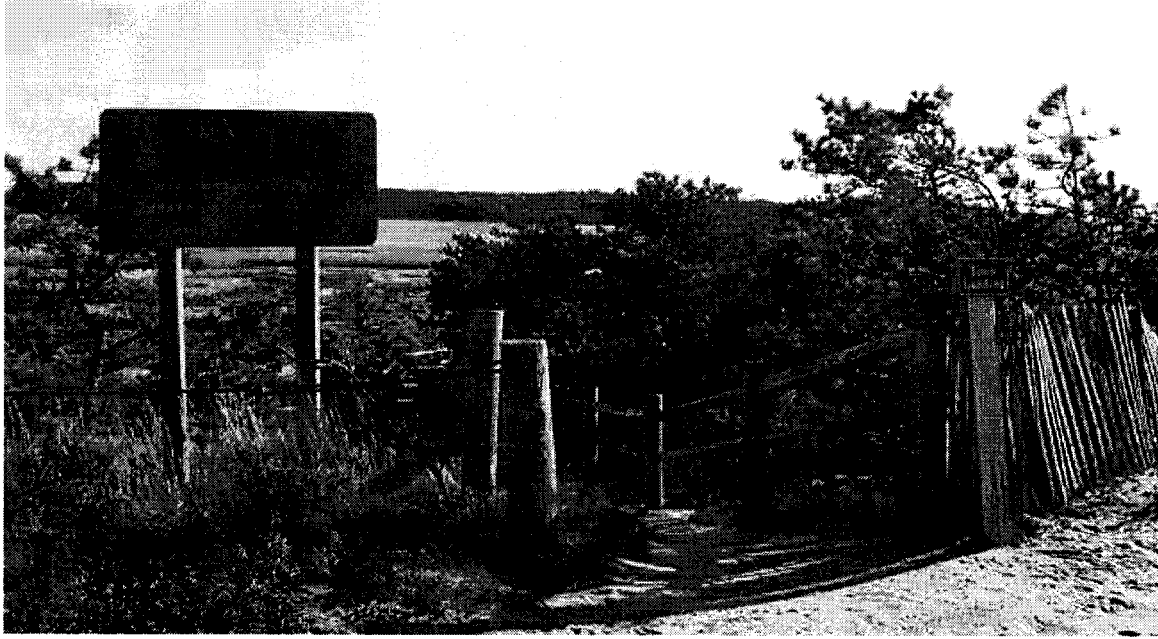
**Figure 2.19: Wooden fence that leads to path/road behind the barrier.**
