**SEDIMENTATION CONCERNS ASSOCIATED WITH THE PROPOSED  
RESTORATION OF HERRING RIVER MARSH, WELLFLEET,  
MASSACHUSETTS**

Prepared for Cape Cod National Seashore, The Town of Wellfleet and The Association  
for Women Geoscientists, as part of a Geologist in-the-park project performed during the  
fall-winter of 2003-2004

*By: Amy J. Dougherty*

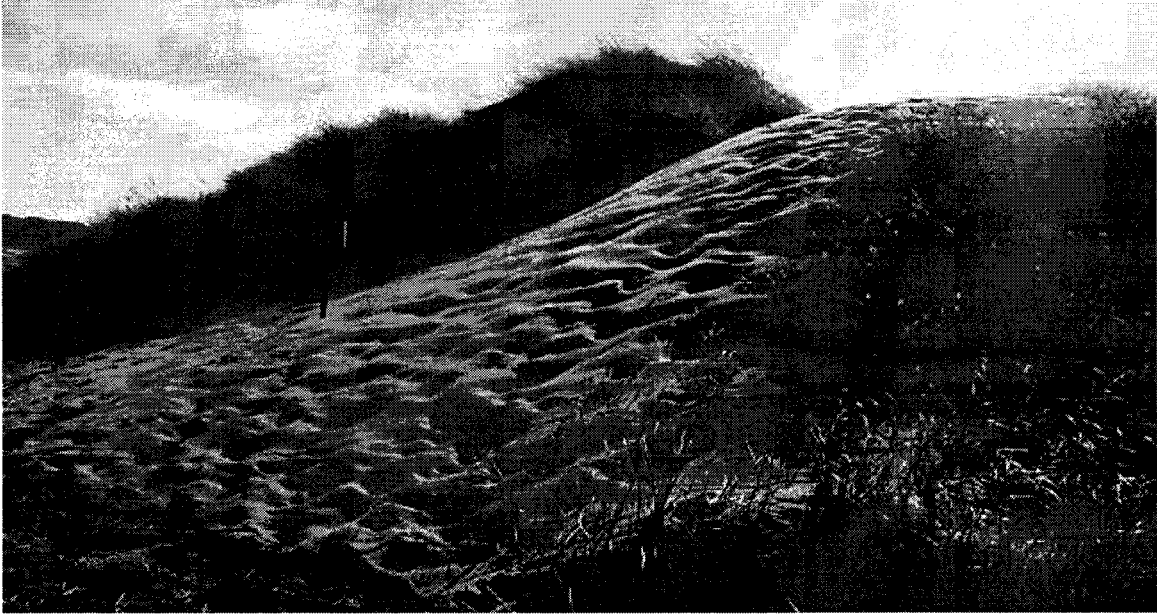
**Figure 2.20: Northern beach access on The Gut as indicated in posted sign.**

In reaction to the degradation of the dune system by pedestrian traffic, steps have been taken by the Town of Wellfleet and Cape Cod National Seashore to monitor this erosion and lessen the anthropogenic impact. Mitigation projects include road and path crossover closures utilizing signage and fences. As a result of the serious problem of blowouts related to foot travel, dune cross-overs for beach access will be limited to only two locations. These formalized crossovers are marked with signs (Figure 2.20) and string to provide “symbolic” fencing (Figure 2.21) making the accepted routes more obvious to encourage their use. The Town of Wellfleet established the northern route (Figure 2.20), located just south of the old Gut parking lot, many years ago. A second crossover was recently selected at the south end of the tombolo (Figure 2.21). The placement of these walkways at the ends of the Gut is not only convenient, i.e. closest to the parking area and to Great Island, but also environmentally optimal, i.e. adjacent to the widest expanses of storm-resistant salt marshes (Figure 2.22). In addition, the paths have a meander or zigzag pattern that should minimize erosion by wind and water (Figure 2.23).

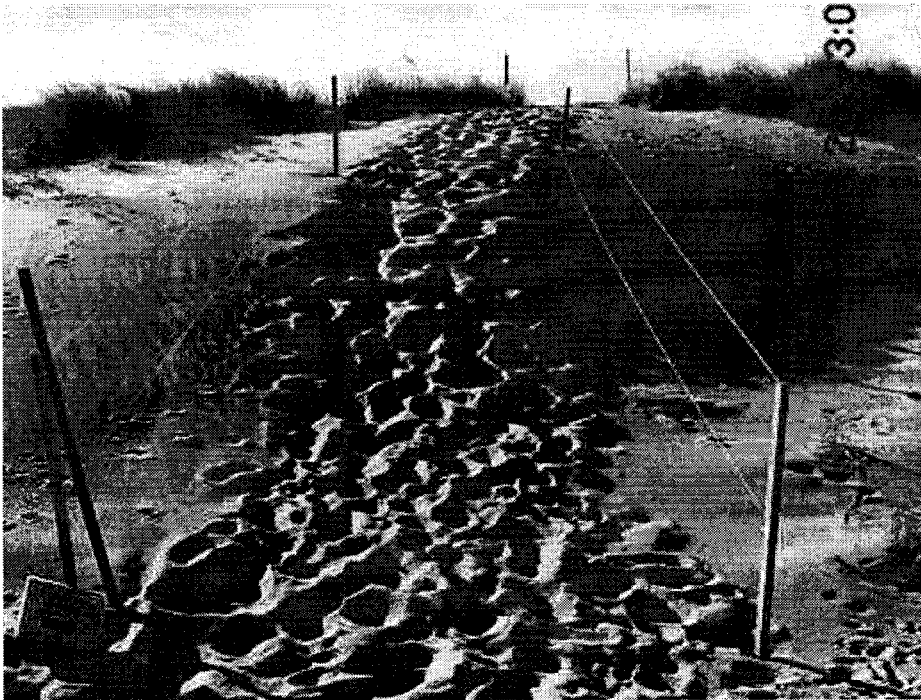
**Figure 2.21: Southern beach access marked by signs and symbolic fencing.**

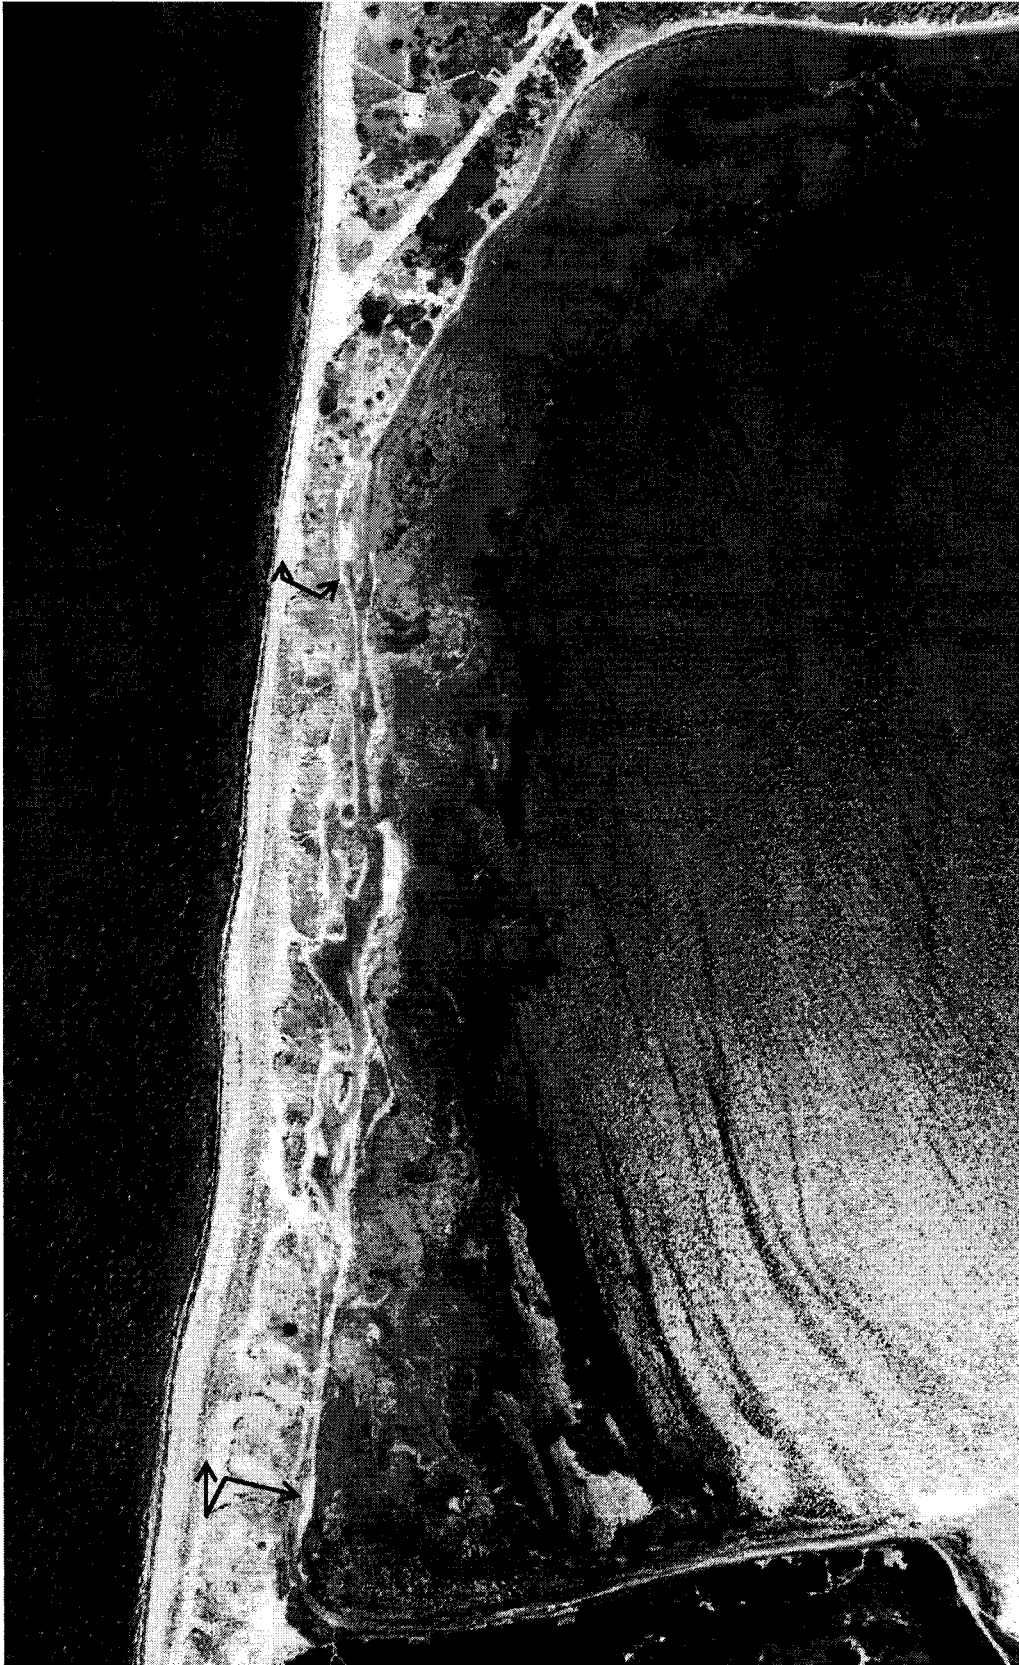
**Figure 2.22: Location of north and south crossovers established along The Gut.**

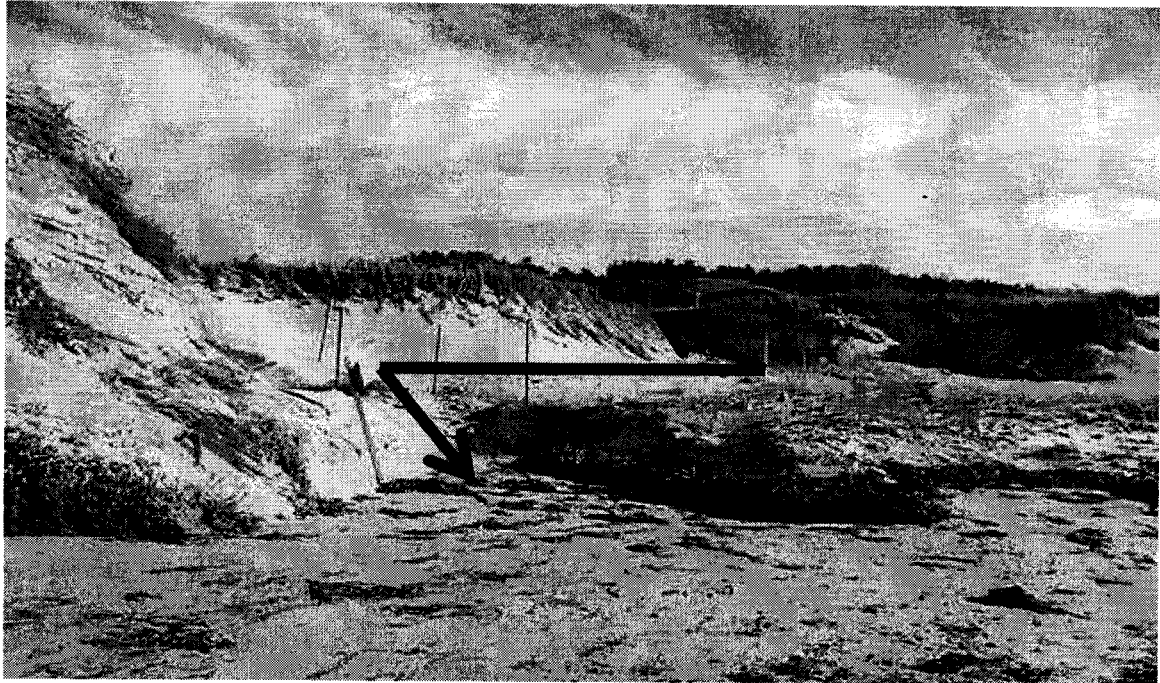
**Figure 2.23: Photograph looking east of the southern beach access on the Gut. Note the meander or zigzag pattern of the path, highlighted in red.**

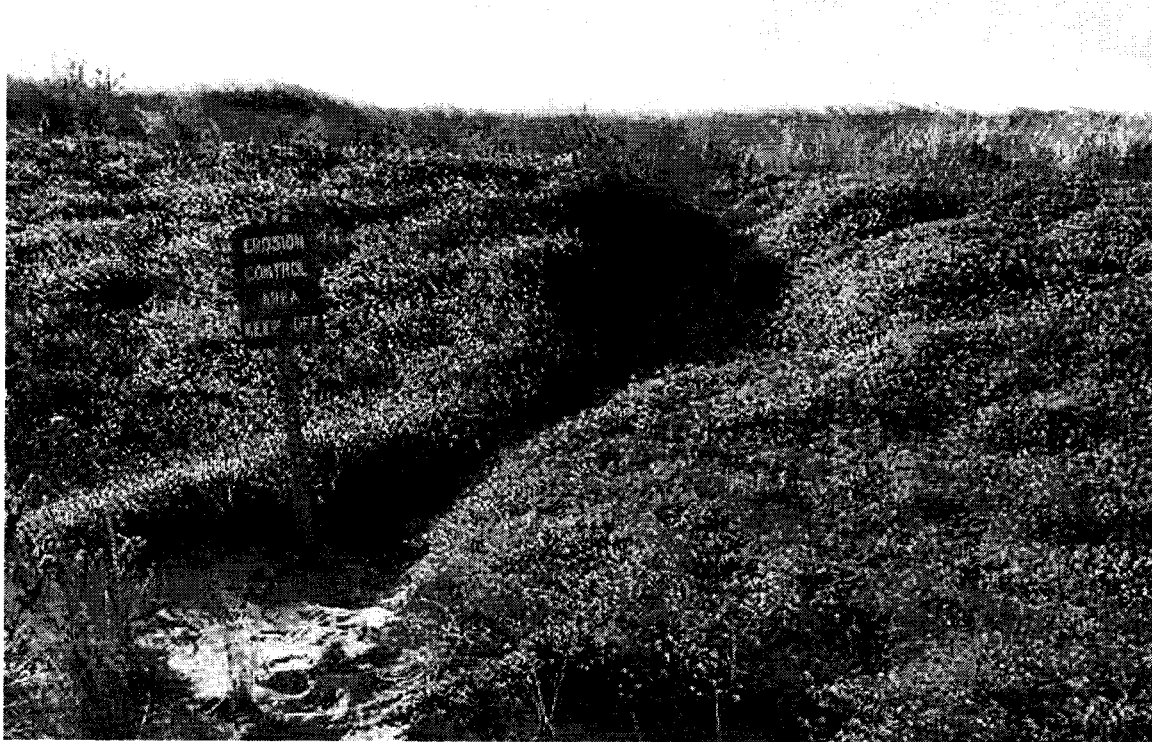
**Figure 2.24: Signs successfully deter pedestrians and promote natural revegetation.**

In areas that have formed paths or blowouts in the more vulnerable central portion of The Gut, restoration projects were undertaken. The largest blowout, located on the southern portion of The Gut, has been sectioned off with dune/snow fencing to both block traffic and capture sand (Figure 2.18). In addition to posting signs (Figure 2.24), dune grass was planted to promote sand accumulation and stabilize the dunes (Figure 2.25). These management practices should minimize erosion due to pedestrian traffic on The Gut.

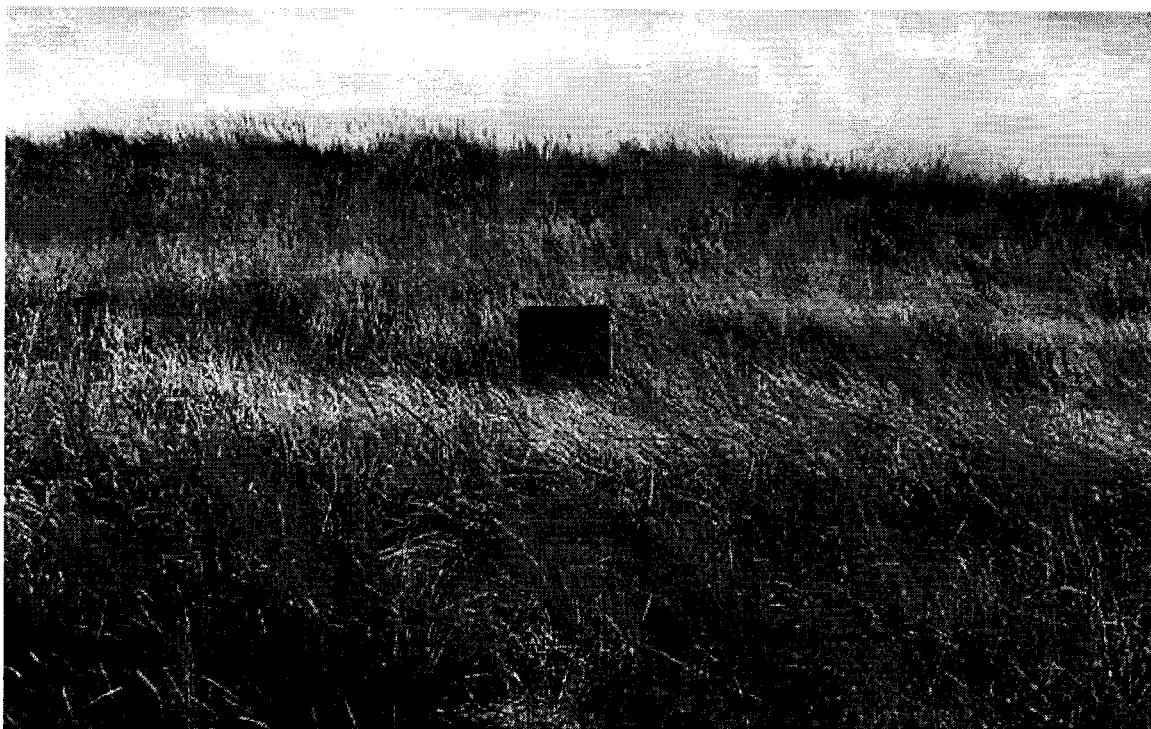
**Figure 2.25: A dune stabilized through signage and revegetation programs.**

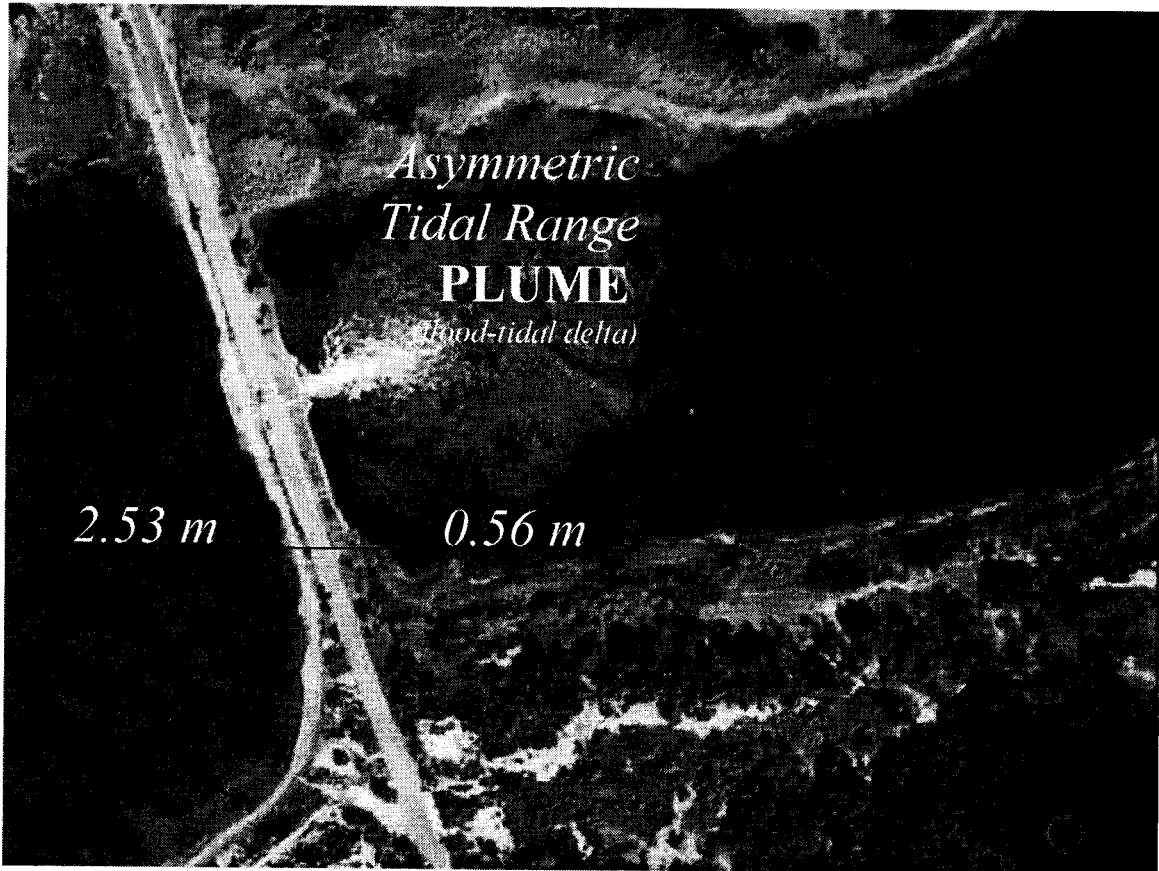
**Figure 3.1: Aerial photograph of the Herring River Dike during flood tide showing the flood-tidal delta. Sediment accumulates above, rather than below, the dike because flood-tide velocities are higher and thereby transport more sediment than ebb tides (Figure 3.2).**

The dike across the mouth of the Herring River has reduced the tidal range above the structure by greater than 4.5 times (Figure 3.1). The difference in tidal range from 2.53 meters below the dike to 0.56 meters above the dike, causes an asymmetry between the flood and ebb flow velocities in the lower portion of the river. The faster flood currents, particularly during very high and storm tides, result in a dominant transport of sediments in an upstream direction. Once sediment-laden water enters the sluice gate the constriction of flow causes the water to speed up, much like putting your finger over a garden hose causes the water to spray out. With this increased flow, sediment is rapidly transported through the dike and into the relatively unconfined, large portion of the lower river. The entrance into this comparatively quiet water causes the flow to disperse, much like the jet stream of a Jacuzzi dissipates with distance, and forms what is known as a plume (Figure 3.1). As the plume velocities and turbulence decrease away from the sluice opening, suspended sediment settles. The larger grains settle first and are deposited just landward of the dike in a fan or triangular shape bedform, similar to a delta at the base of a river. The finer grains are carried farther and deposited just upstream of the delta. This system is more analogous to a tidal inlet than a river mouth because of the confined bi-directional flow created by the tides. In sticking with the model of a tidal inlet, this sedimentary deposit above the dike will be called the flood-tidal delta (Figure 3.1 & 3.2).

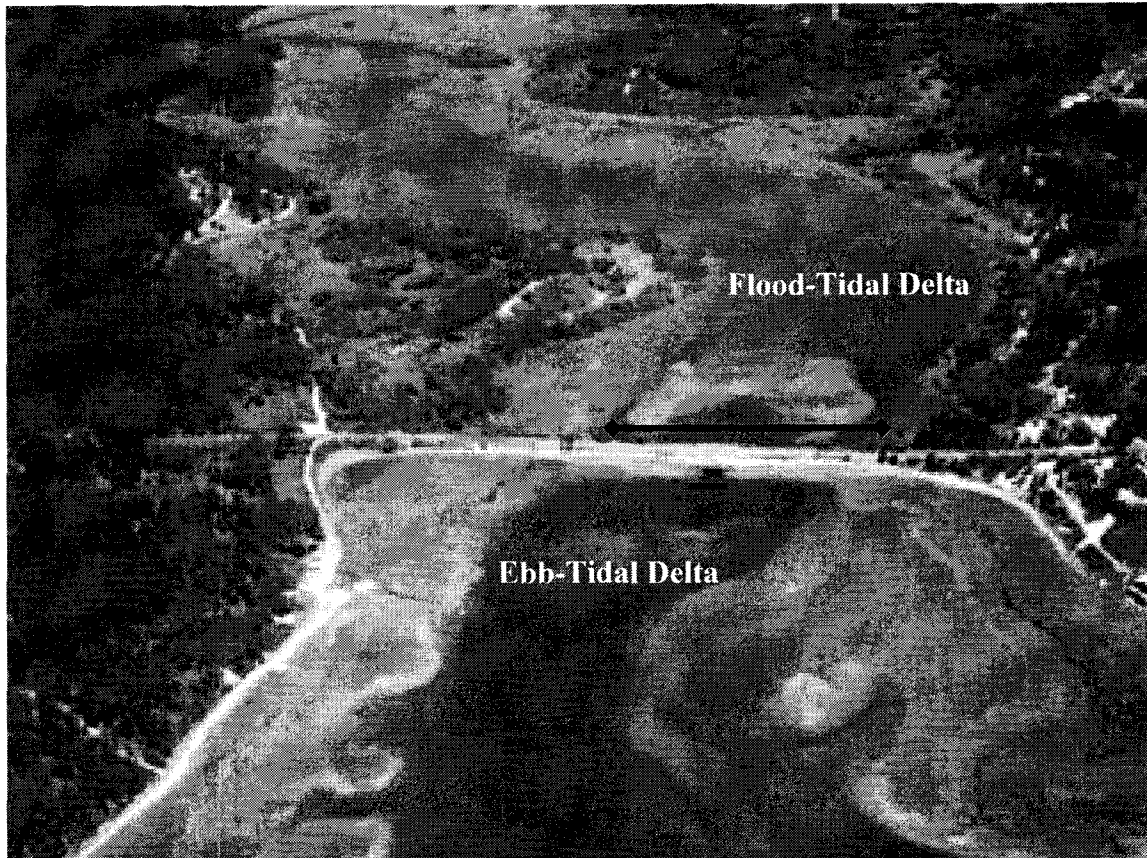
**Figure 3.2: Air photograph showing the location of the flood-and ebb-tidal deltas, as well as the reduction in width of the river (black line with diamond end points located above the road) to the small opening of the dike (black line below the road).**

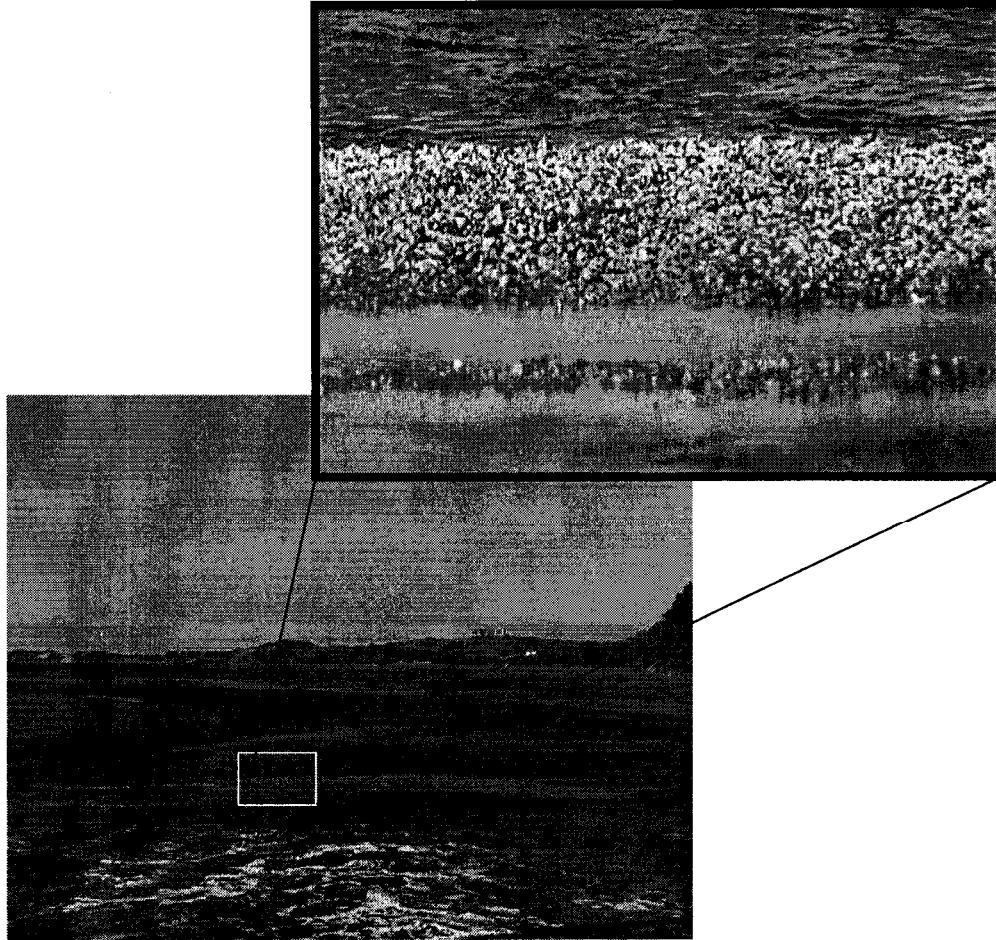
**Figure 3.3: Digital photo of ebb-tidal delta armored with shellfish.**

This lack of sediment moving in a downstream direction prompts the question of why an ebb-tidal delta exists at all. It is thought that both deltas initially formed when the dike was built and flow was constricted to one small area (Figure 3.2). Erosion caused by the focused flows scoured a channel proximal to the culverts and perpendicular to the dike. The scoured material was then deposited at the upstream and downstream ends of the channel, forming the flood-and ebb-tidal deltas respectively. Once the channel became established and the area reached equilibrium, little additional sediment was added to the ebb-tidal delta allowing oysters to colonize it (Figure 3.3). In contrast, the flood-tidal delta continues to grow by the constant addition of sediment brought in from the ocean, preventing colonization by oysters.

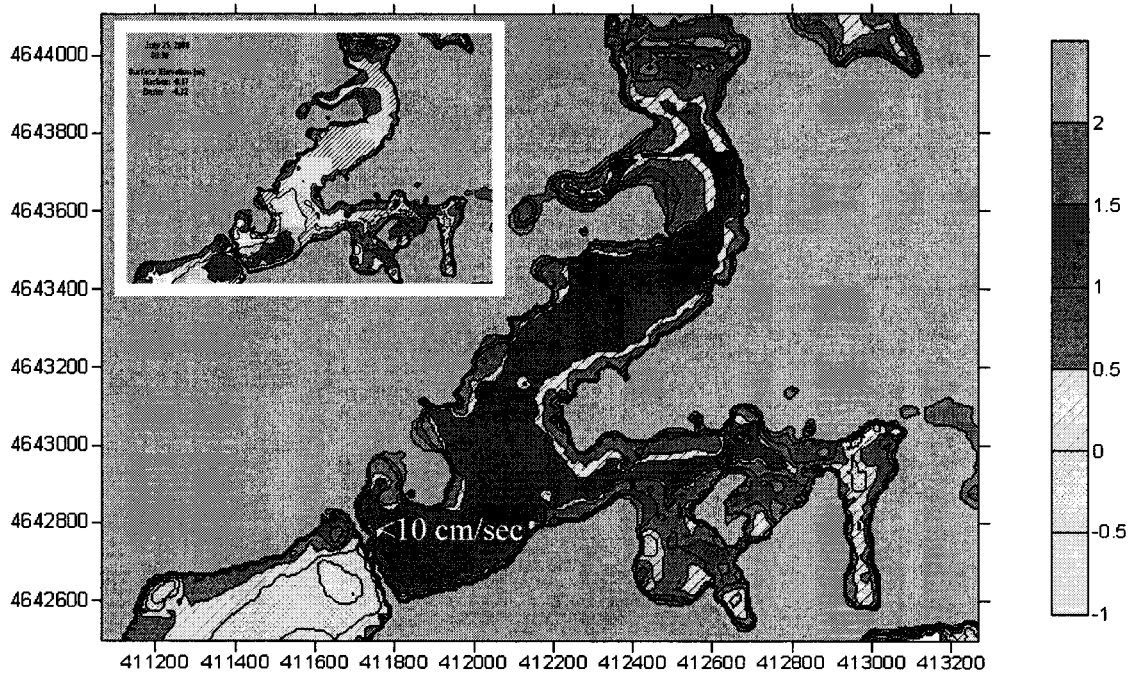
**Figure 3.4: Snapshot of Spaulding and Grilli's hydrodynamic model that predicted maximum velocities above the dike, with all gates open, to be less than 10 cm/sec.**

Spaulding and Grilli's (2001) extensive hydrodynamic study measured the velocities of the ebbing tides proximal to the flood-tidal delta and found them to be insufficient to resuspend the sediment within the delta or the fine-grained material just upstream of it. These currents will be reduced even more if the dike is opened to allow more water to flow through the structure. In keeping with the above hose analogy, the situation is likened to taking your thumb off of the nozzle, thus increasing the opening and causing the water to stop spraying and to return to a slower flow. Although increased sluice gate openings will cause water velocities through the dike itself to decrease, both tidal range and current velocities will increase in the river upstream of the dike; however, flows will still be far too slow to resuspend sediment. Spaulding and Grilli's study determined peak velocities in the river with all three dike gates open to be less than 10 cm/sec, which is half the 20 cm/sec necessary to resuspend sand within the river (Figure 3.4).

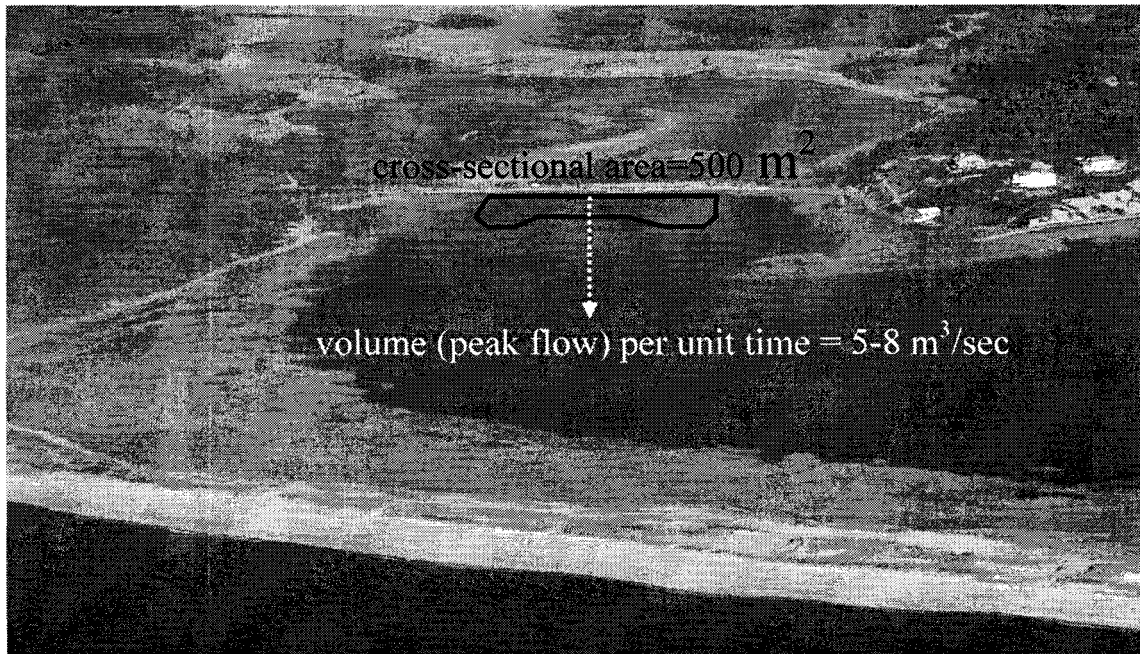
**Figure 3.5: Pictorial display of the variables determining peak velocity in the river channel below the dike.**

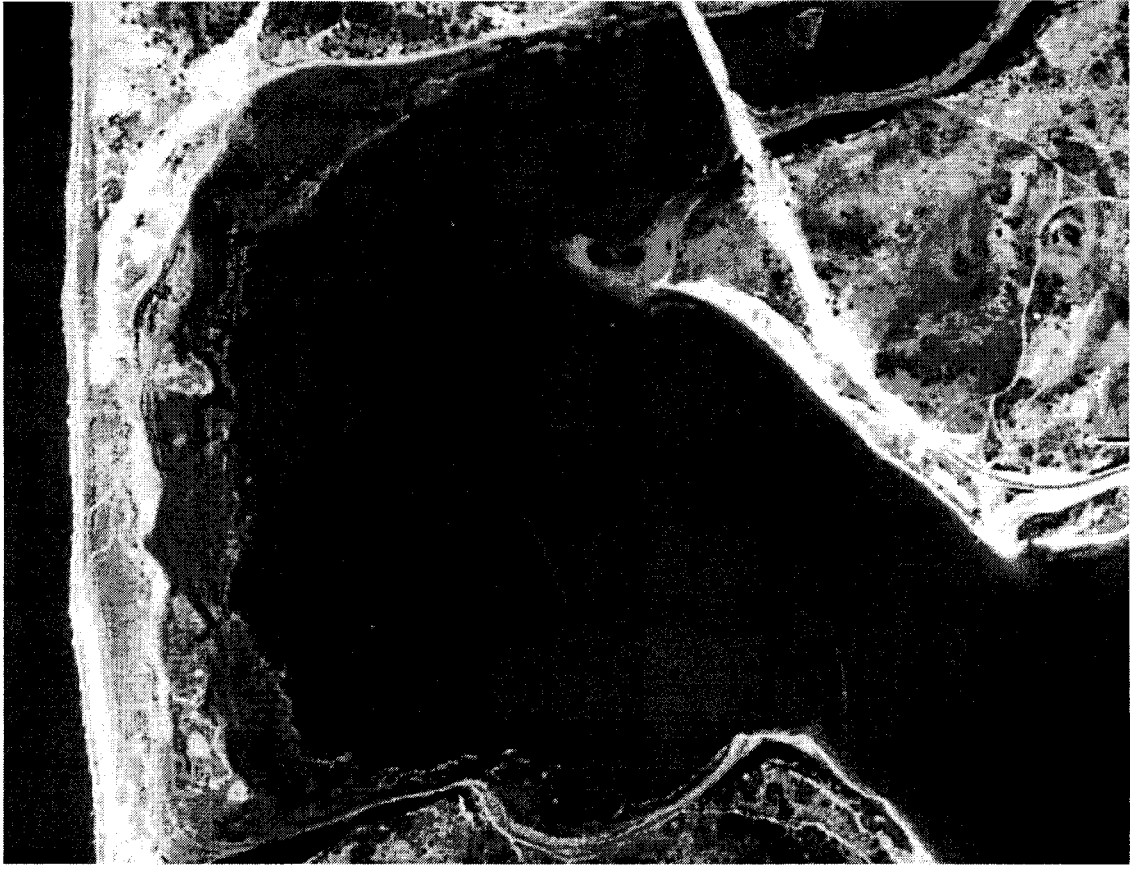
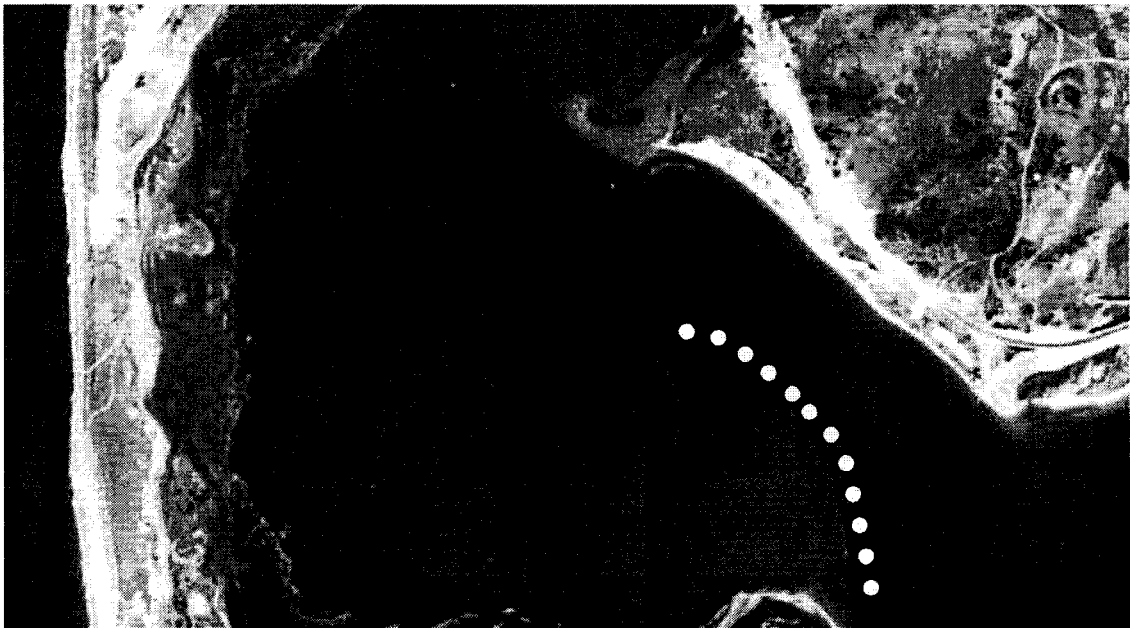
**Figure 3.6: This is the first air photograph of Herring River taken in 1938, 30 years after the dike was constructed. It is hard to see what the configuration of the intertidal area is due to it being high tide, but you can make out what seems to be part of the main ebb channel marked by white (or yellow) dots.**

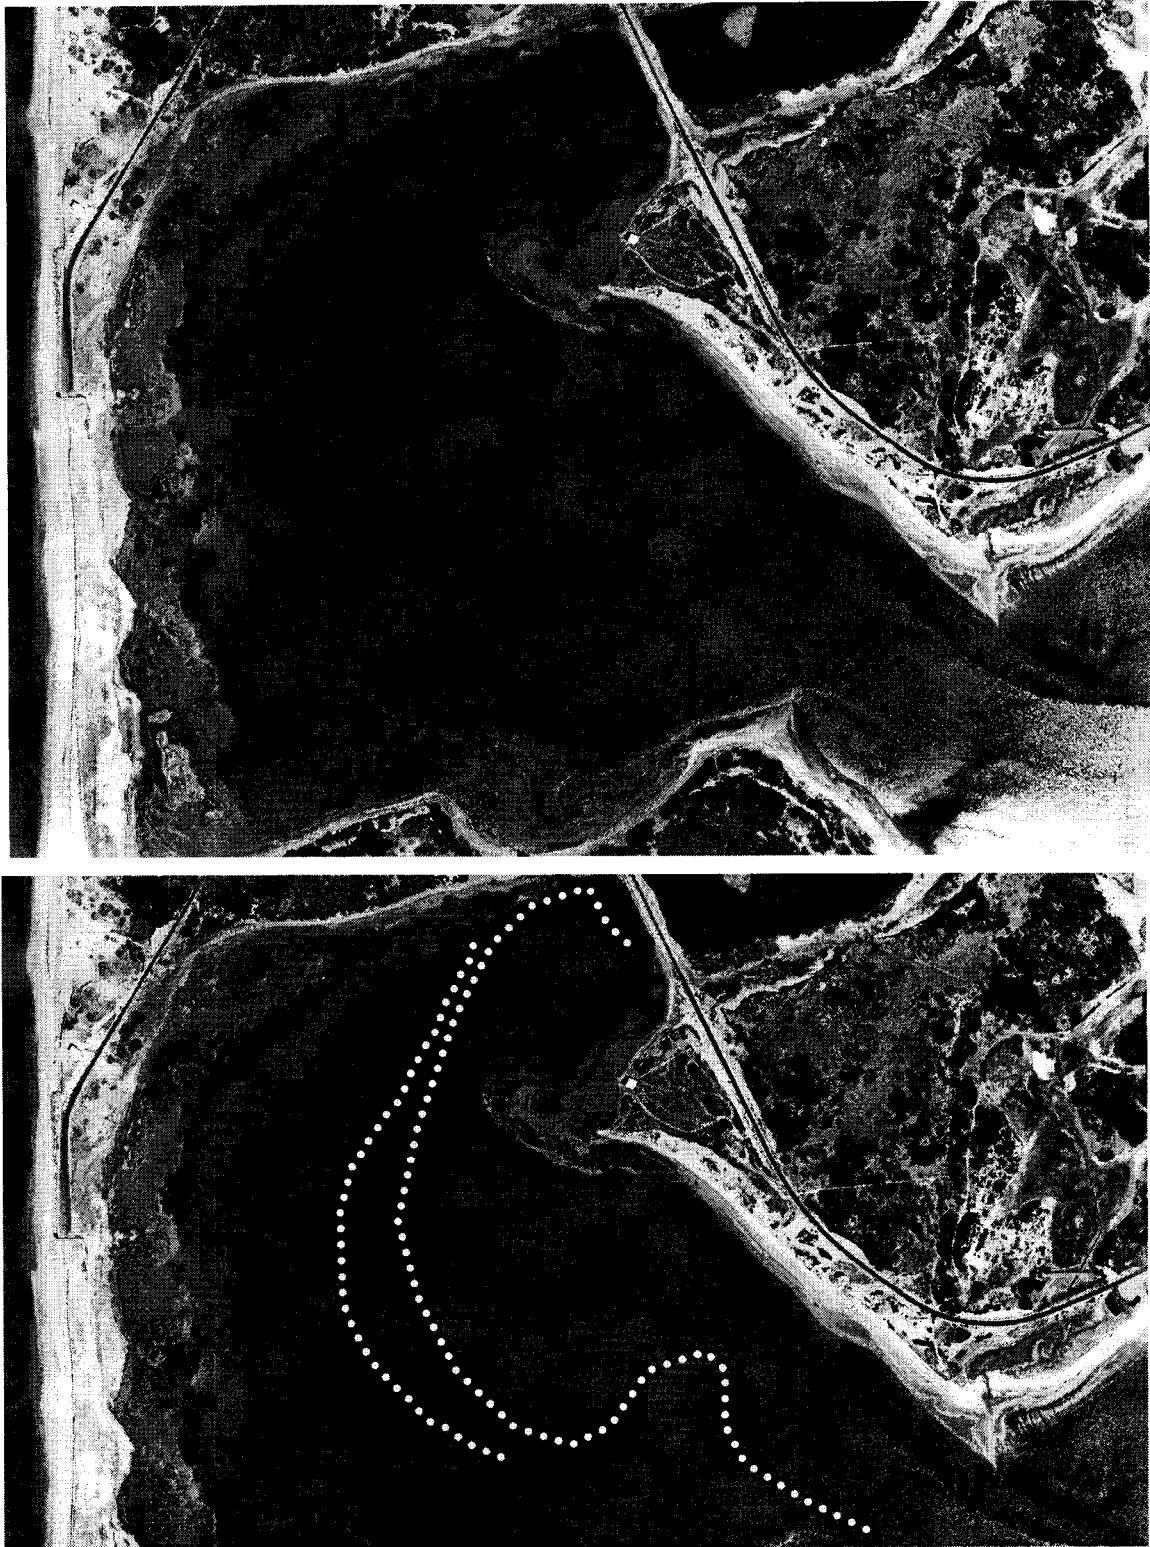
**Figure 3.7:** This 1960 air photo was taken at a slightly lower tide and you can start to see the whole length of the main ebb channel and the possibility of a second channel. For reference this is the last photo taken before the dike breach in 1968.

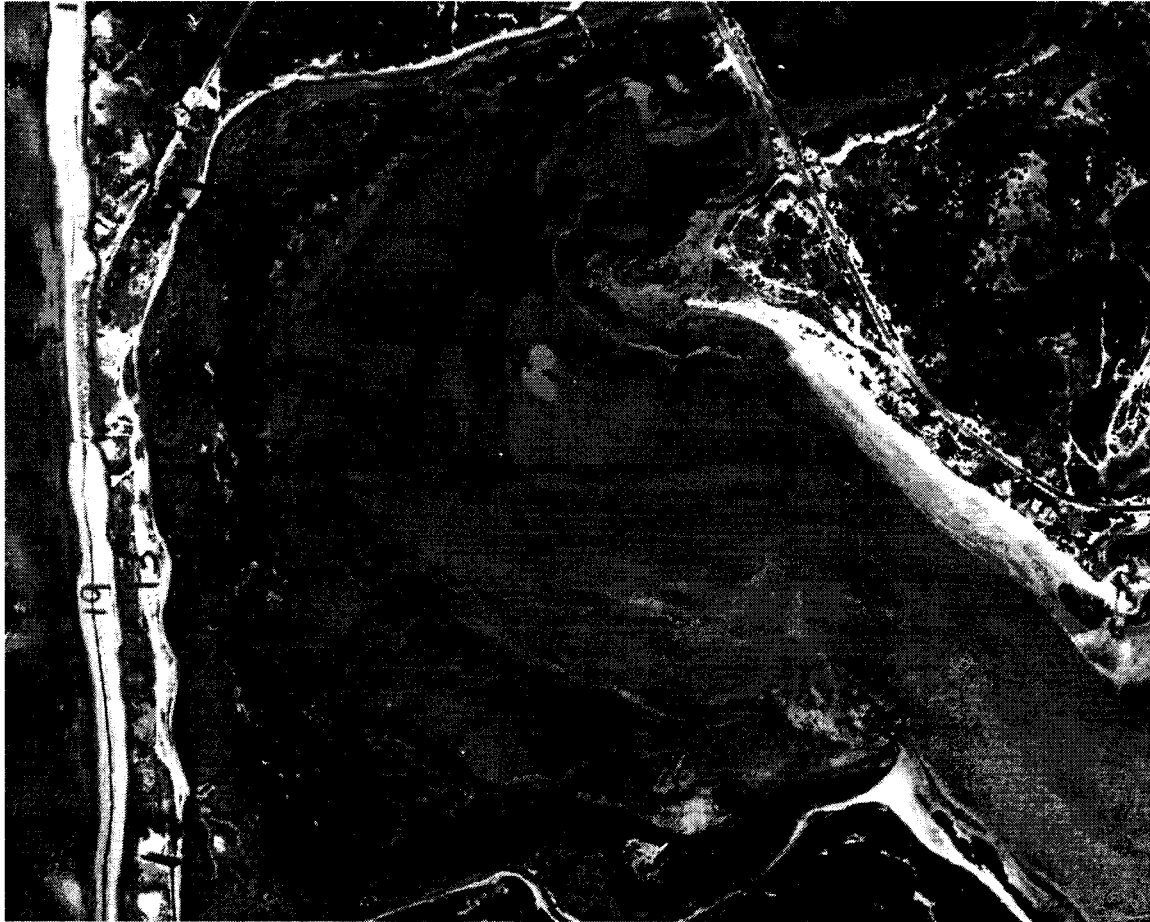
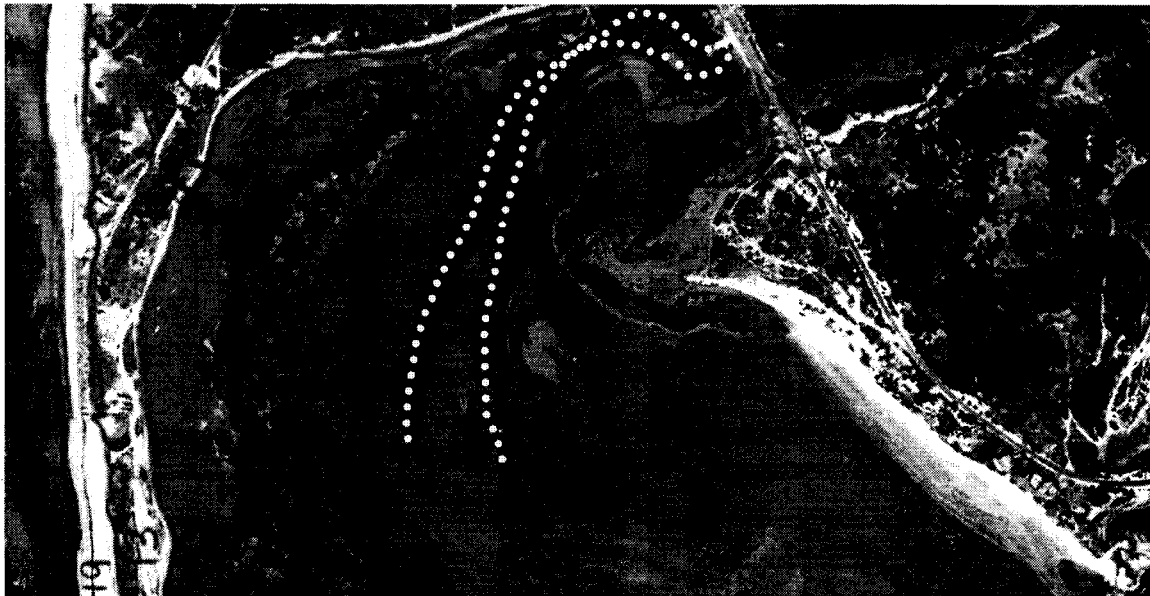
**Figure 3.8: 1977 air photo taken just after the dike was rebuilt following the breach. This low-tide shot shows that the main ebb channel, while maintaining the same shape, actually splits in two just below the dike.**

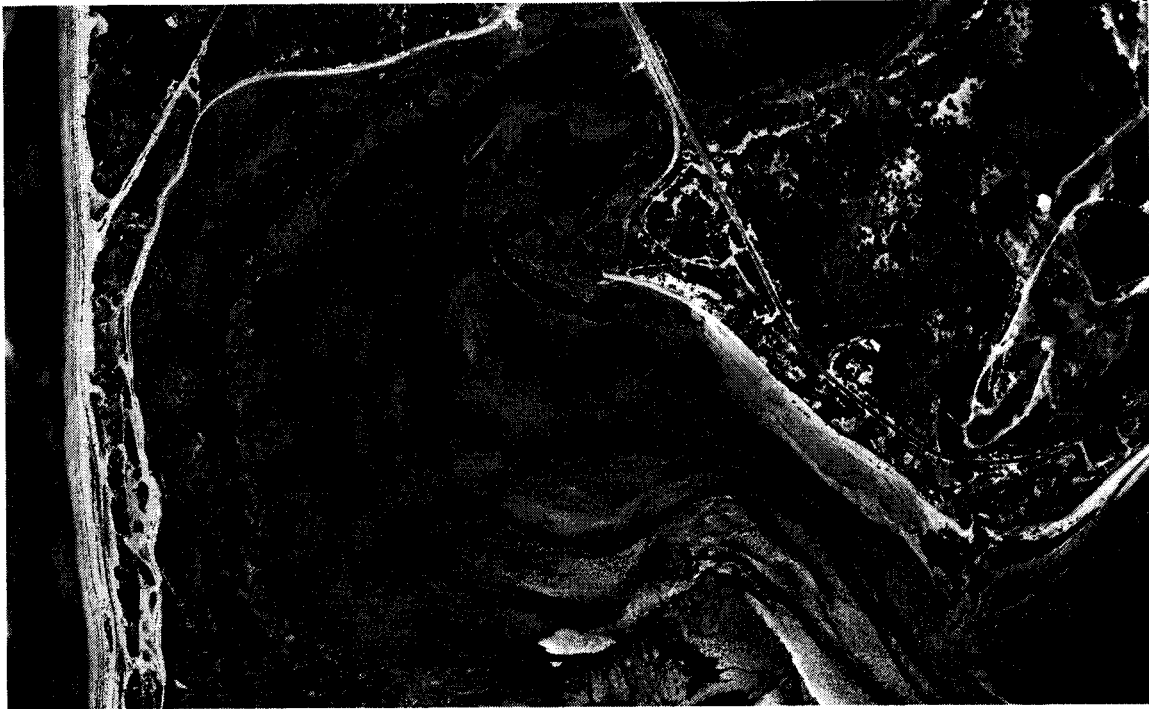
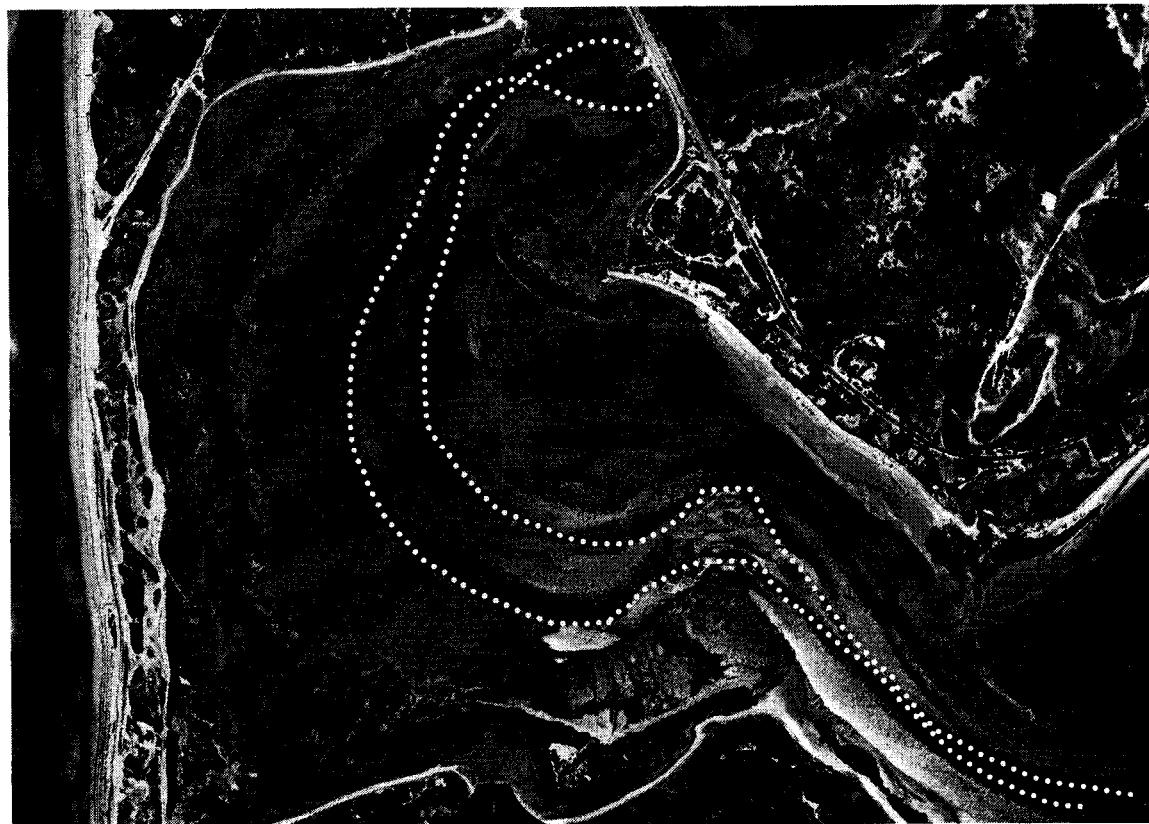
**Figure 3.9:** This 1987 air photograph, taken at the lowest tide in the series, shows the same main ebb channel morphology as the rest and also the split seen in 1977. This photo was taken over ten years after the dike was repaired following the breach.

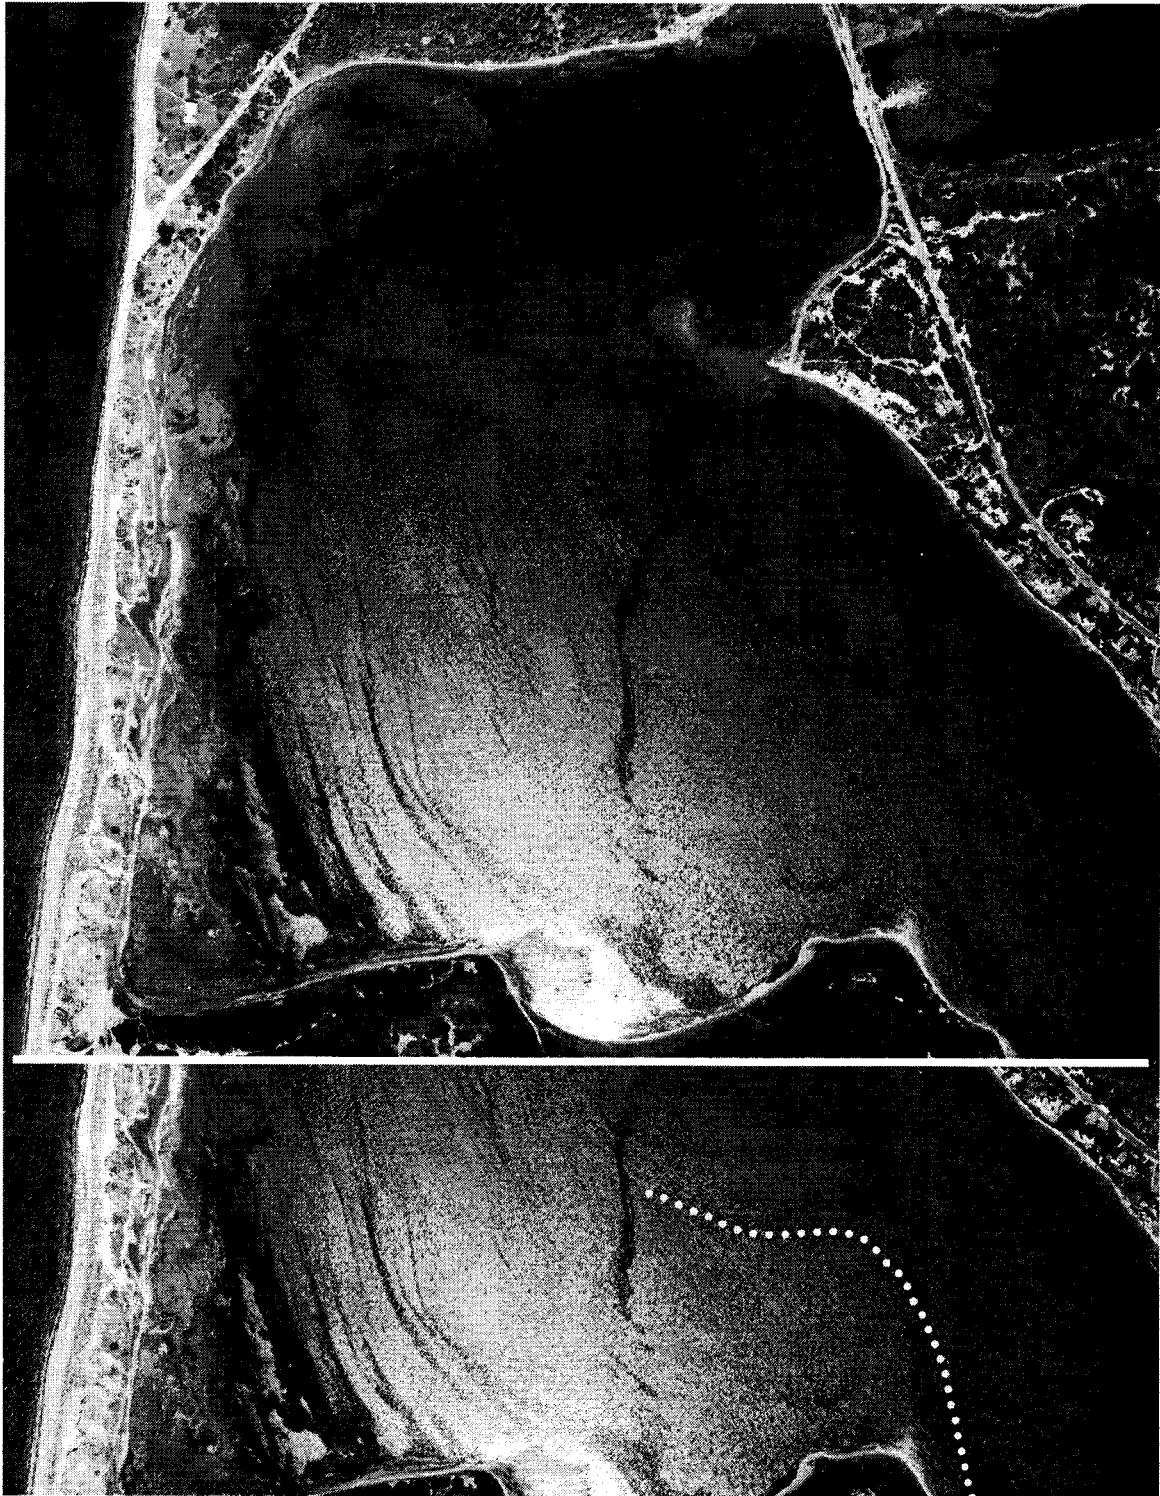
**Figure 3.10:** This 1991 air photo was taken at high tide, thus restricting the view of the intertidal morphology with the exception of possibly the lower channel like 1848 (Figure 3.13).

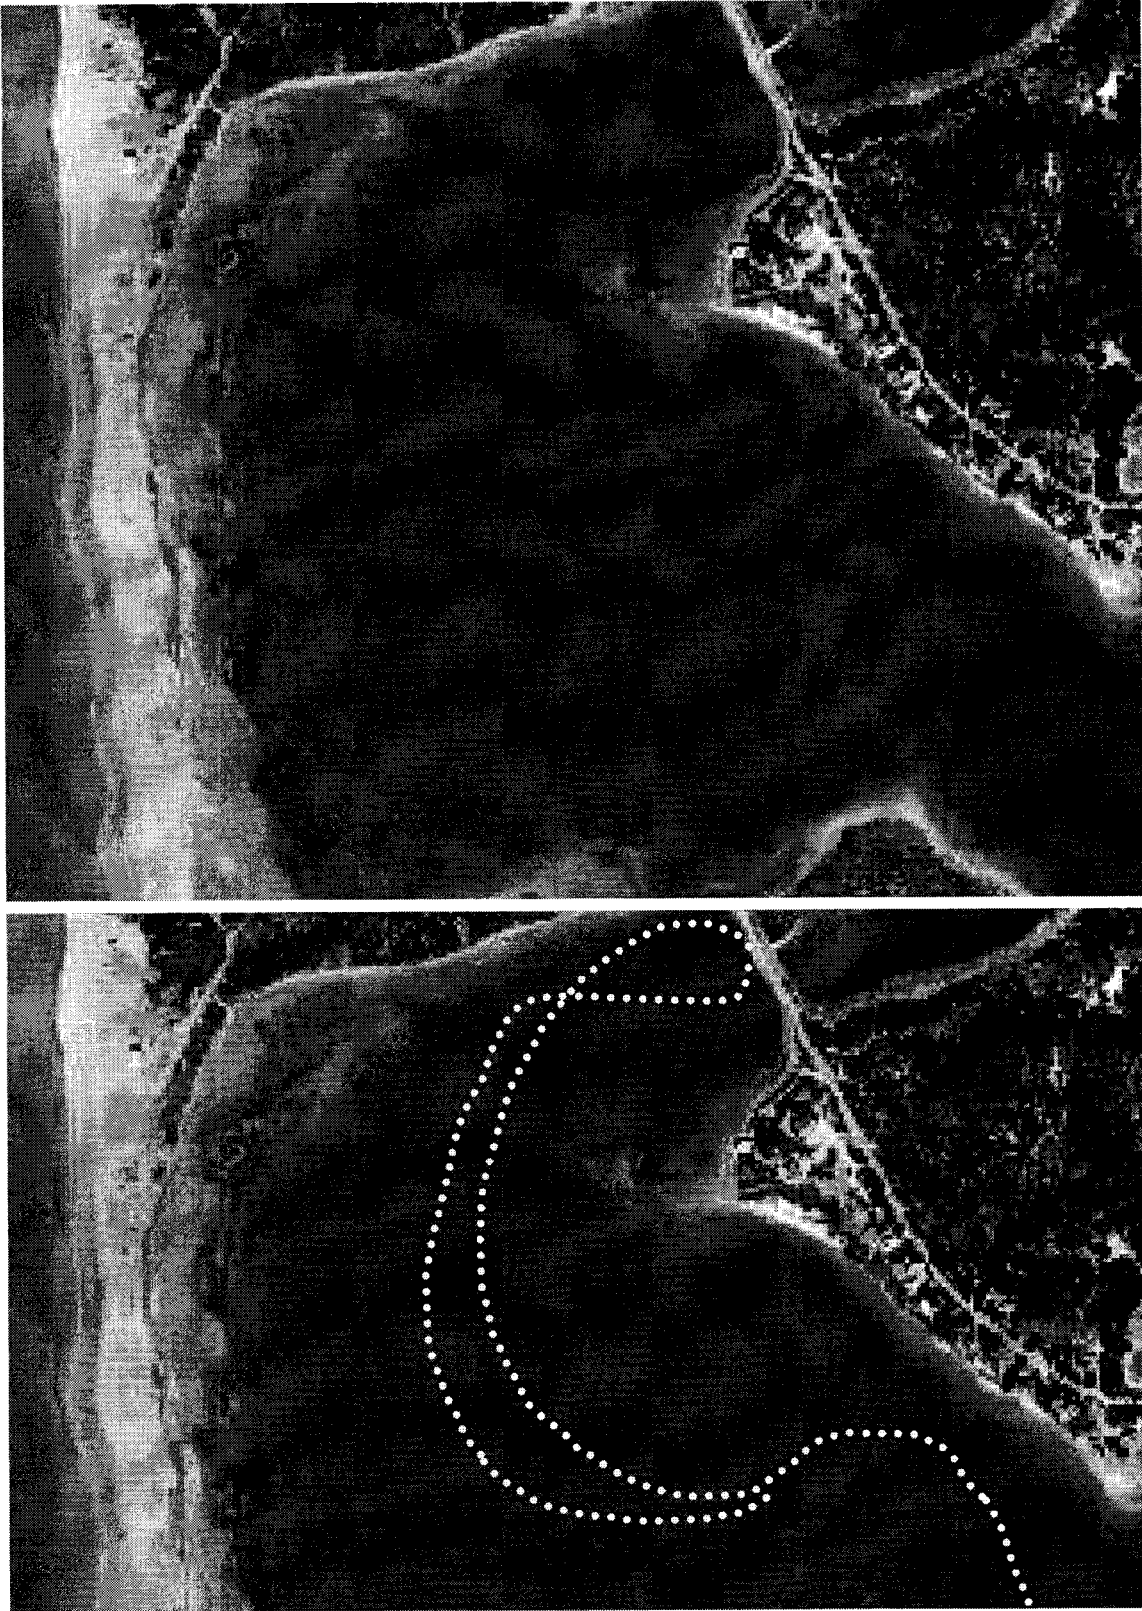
**Figure 3.11: This 2001 air photo was taken at about mid-tide revealing the same configuration and faint impression of the duel channels as seen previously.**
