**SEDIMENTATION CONCERNS ASSOCIATED WITH THE PROPOSED  
RESTORATION OF HERRING RIVER MARSH, WELLFLEET,  
MASSACHUSETTS**

Prepared for Cape Cod National Seashore, The Town of Wellfleet and The Association  
for Women Geoscientists, as part of a Geologist in-the-park project performed during the  
fall-winter of 2003-2004

*By: Amy J. Dougherty*

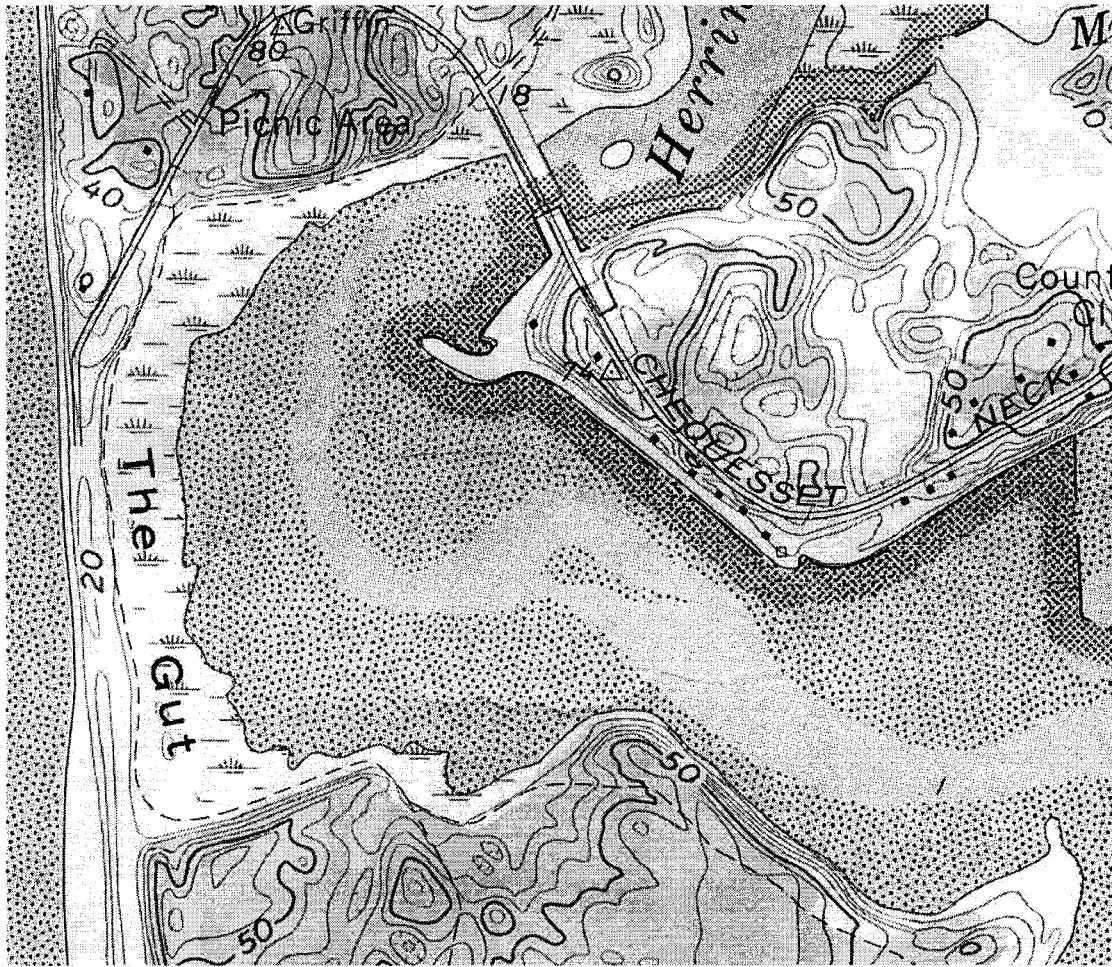
**Figure 3.12: 1974 USGS topographic map showing the configuration of the intertidal bedforms in the stipple pattern. This depiction reveals the same main ebb channel geometry that was evident in the air photographs.**

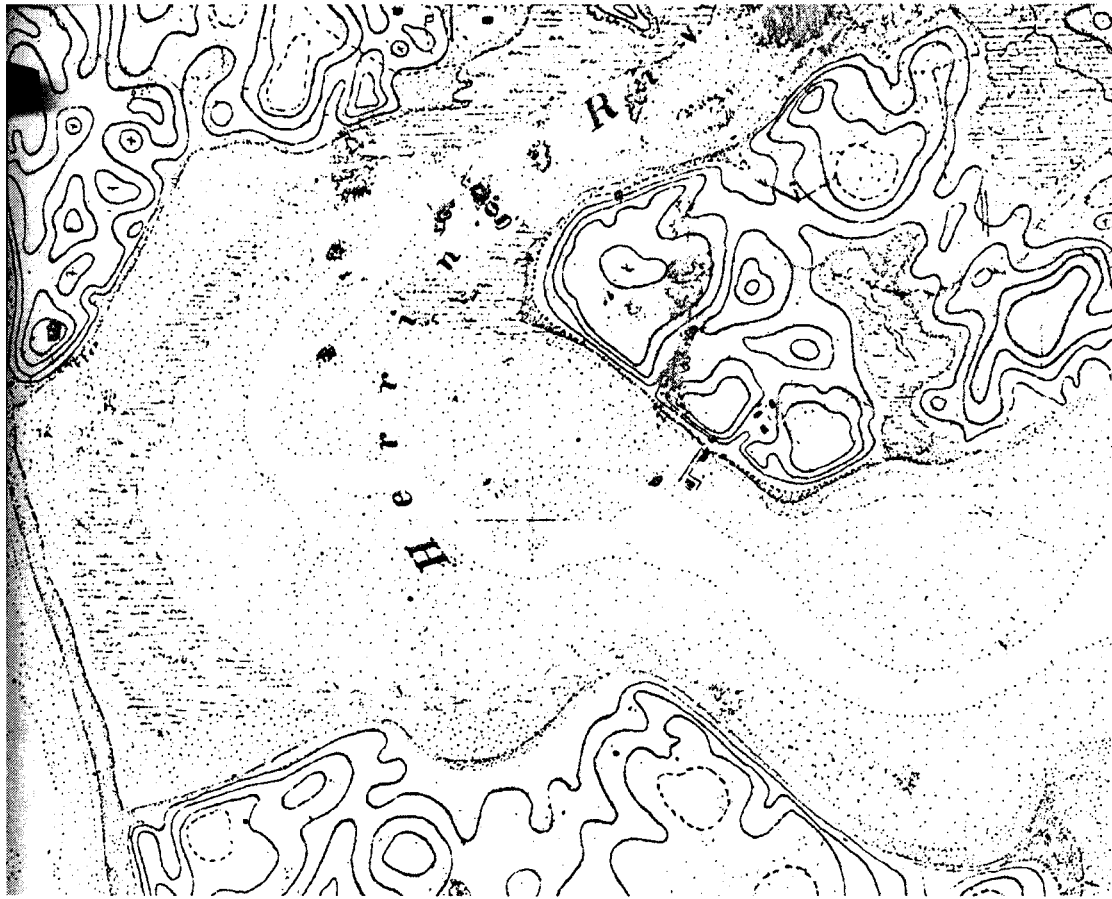
**Figure 3.13: This t-sheet (coastal topographic map) from 1848 shows the intertidal morphology that existed prior to the dike's construction in 1908-1909. The configuration of the main ebb channel has the same s-shape geometry as the post-diked scenario depicted in the 1974 coastal chart.**

**Figure 3.10:** This 1991 air photo was taken at high tide, thus restricting the view of the intertidal morphology with the exception of possibly the lower channel like 1848 (Figure 3.13).

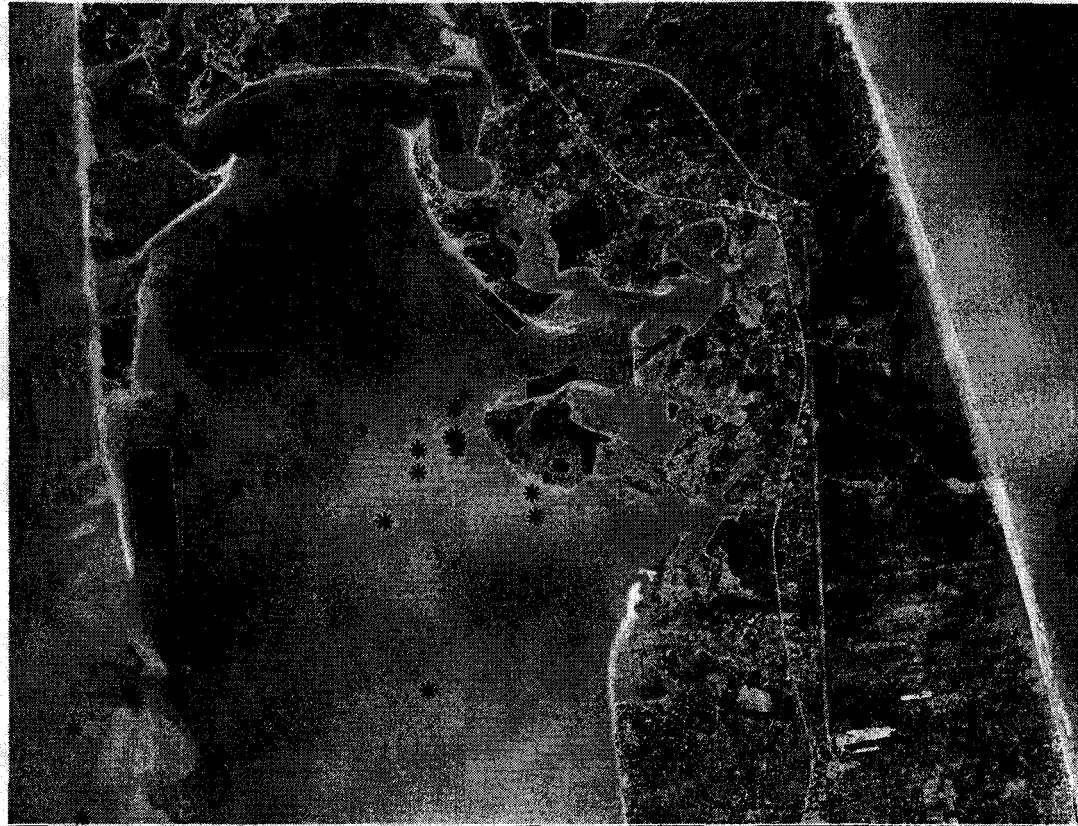
**Figure 3.16: Location map of Wellfleet Harbor marine structures showing that the closest shellfish grant is over a mile away from the Herring River Dike.**

associated with the restoration (Figure 3.16). Shellfisherman that worked Egg Island during the dike breach in 1968 report no change in sedimentation. That is not to say that sediment is not accumulating on Egg Island, but any change in the tidal flats is a result of tidal dynamics in the Harbor and Cape Cod Bay rather than any influence of the Herring River. Indeed, if we compare the configuration of Egg Island from 1848 to 1974 (Figure 3.17), it appears that little has changed. By virtue of the fact that sea level is rising on an average of 2.5 mm/year in this area, sediment must be accumulating on these intertidal flats to keep them from becoming subtidal. Thinking back to sediment movement along the Cape, which was discussed in the previous chapter, sand is moving southward along Wellfleet's Cape Cod Bay beaches. The sand that is not incorporated into the barrier beaches connecting the Wellfleet Harbor islands is carried either into the harbor or the bay. Looking at a sediment transport map (Figure 3.18), large bedforms, known as sand waves, indicate the direction that sand is moving. This movement is indicated on the map with arrows sized to represent the sizes of the bedforms. All of these arrows show that the net landward movement of sand is coming along Cape Cod Bay beaches and into the harbor. Close study of these bedforms suggests that over time these sand waves have been stationary, indicating that the harbor has reached an equilibrium in which the sediment transported into the harbor is simply keeping up, or building vertically (aggrading), with sea-level rise. It is the tidal forcing of bay and harbor, and not the Herring River, that shapes Egg Island and the rest of the intertidal flats in Wellfleet Harbor (Figure 3.19).

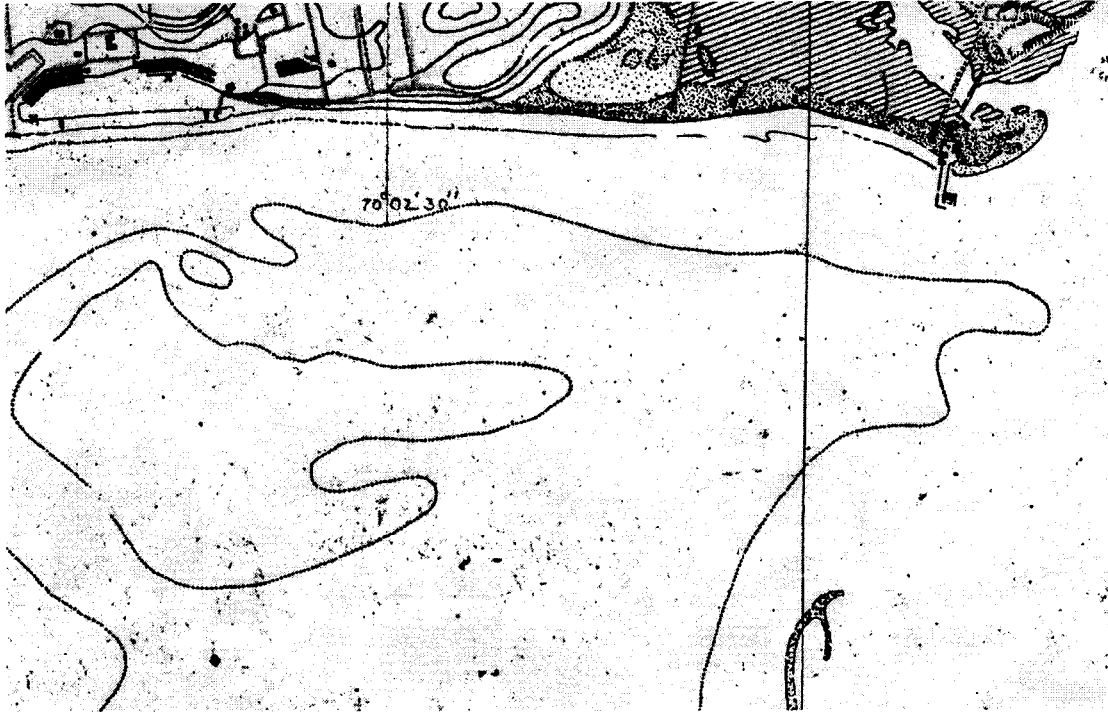
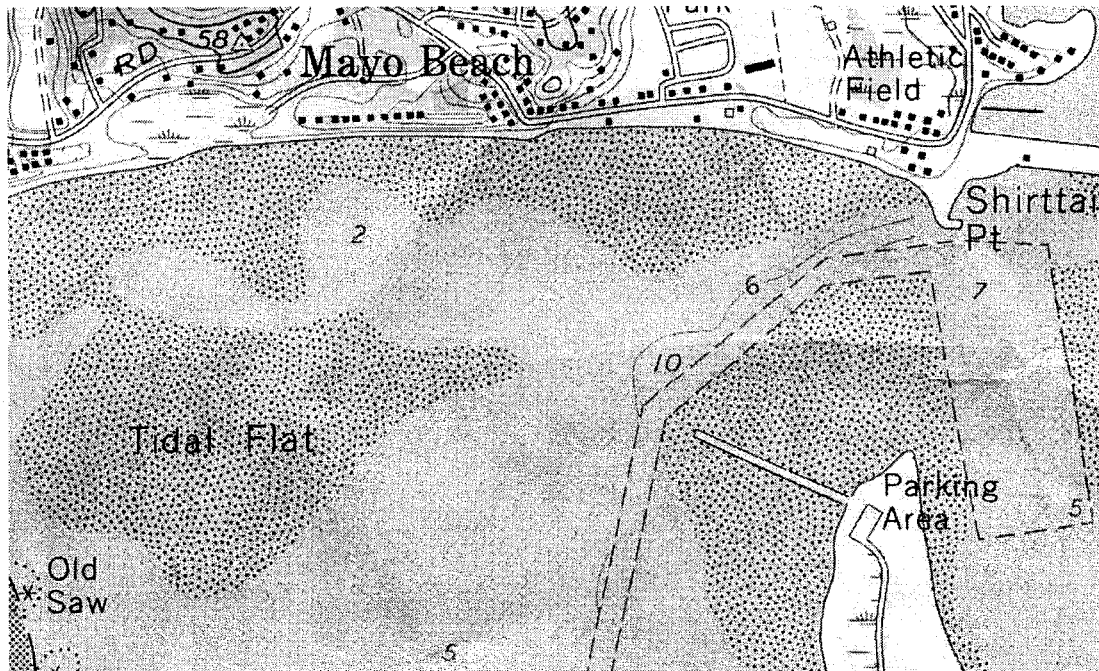
**Figure 3.17: Comparison of maps from 1848 and 1974 in the area of Egg Island and the northeast part of Wellfleet Harbor reveals similar intertidal morphologies.**

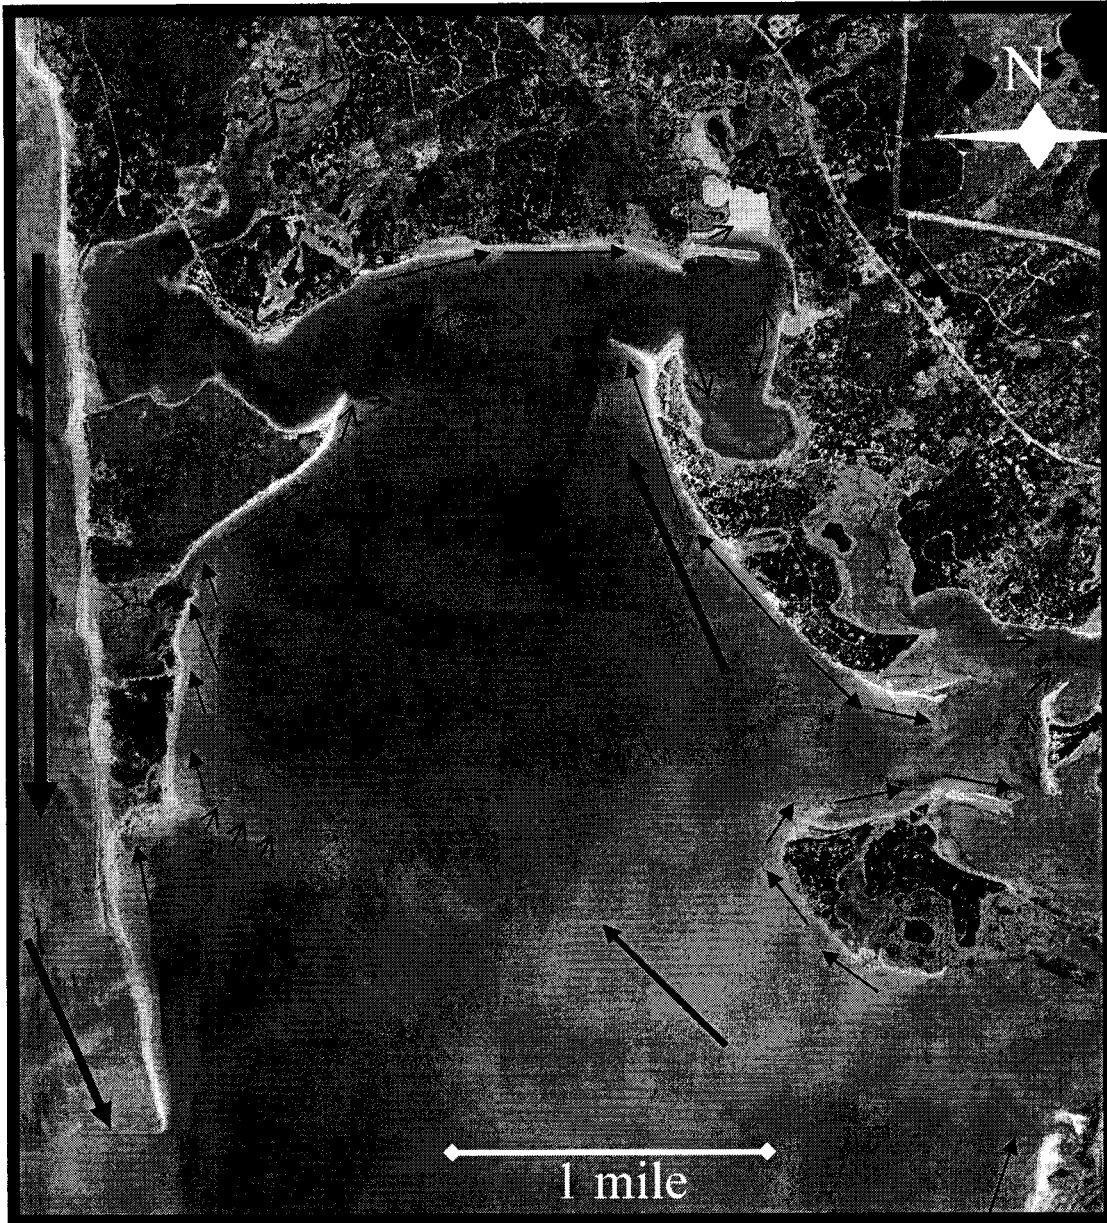
**Figure 3.18: Sediment transport map of Wellfleet Harbor that shows the dominant direction of transport is from Cape Cod Bay up into the Harbor and Herring River.**

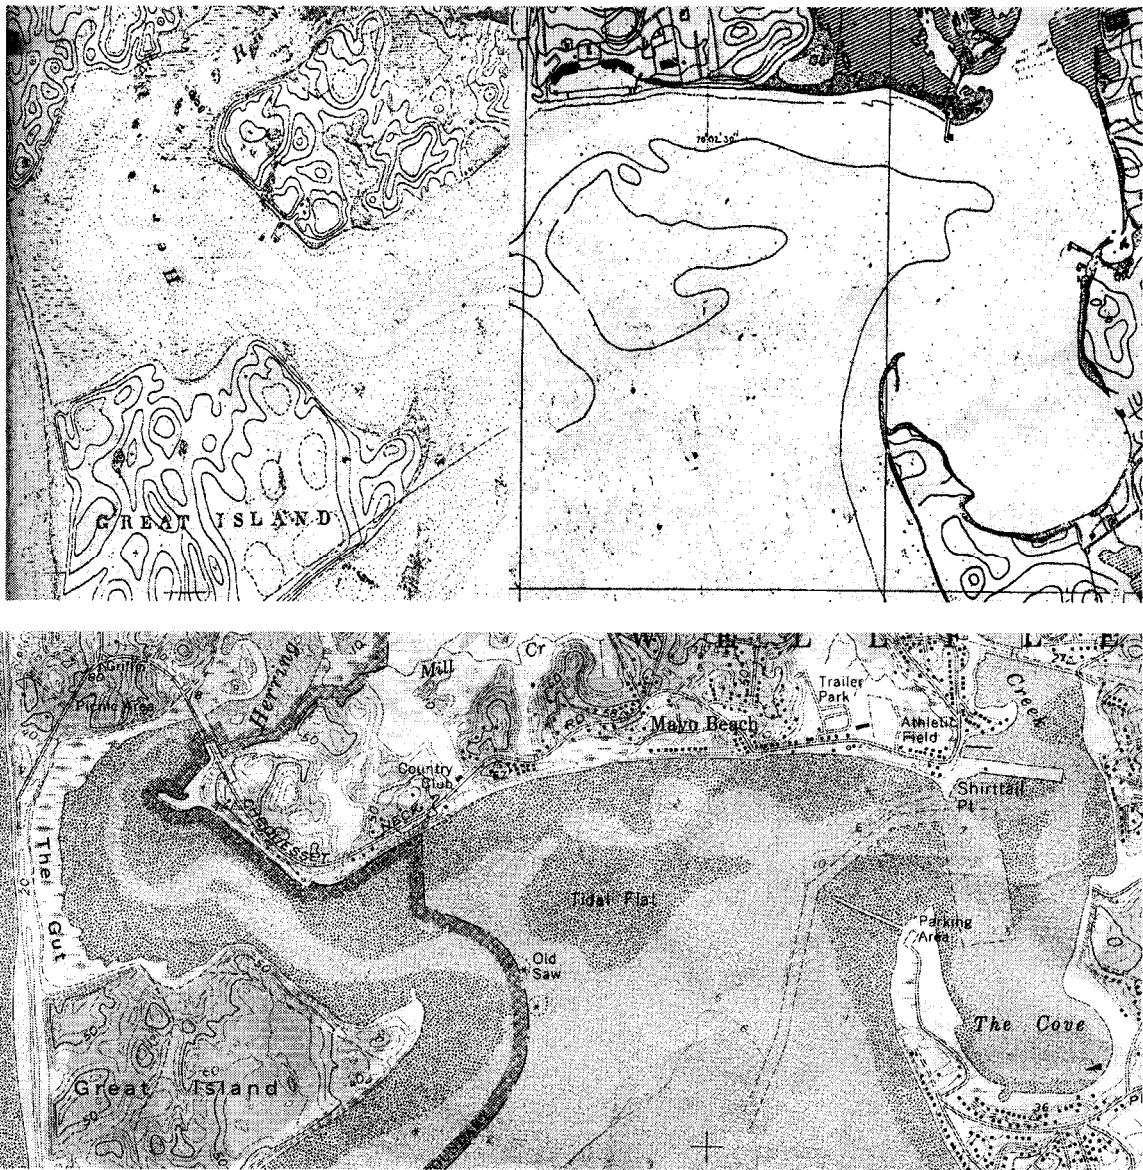
**Figure 3.19: Comparison of coastal topographic maps of Wellfleet Harbor from 1848 and 1974 shows similar intertidal morphology over the past 155 years.**

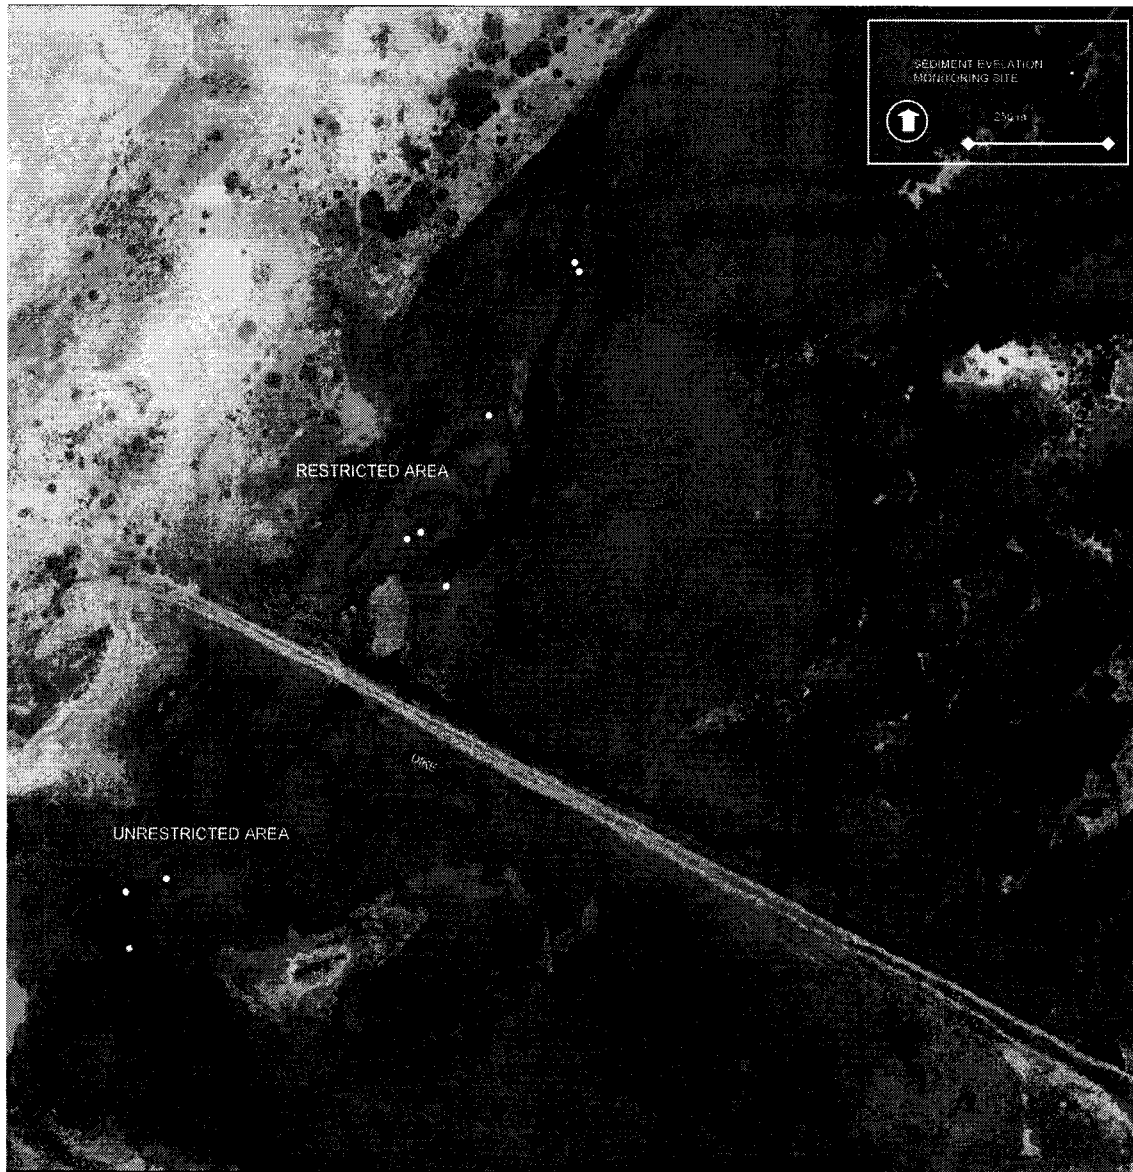
**Figure 3.20: Location of Sediment Elevation Tables (SETs) located within Hatches Harbor (Portnoy, Gwilliam & Smith, 2004).**

dike in the unrestricted marsh, whereas six are above the dike in the restricted marsh (Figure 3.20). Of the six located above the dike, three are near the dike structure and three are located farther away. Looking at a graph of the data for the unrestricted marsh (Figure 3.21), there is a 3 mm/year accumulation of sediment within the marsh, compensating for the local rate of sea-level rise. However, the graph of all the data from the restricted marsh shows considerably more sediment accumulation above the dike (Figure 3.22). This increased upstream accumulation is a result of the dominance of landward sediment transport, just what is predicted for Herring River in the event that it undergoes restoration.

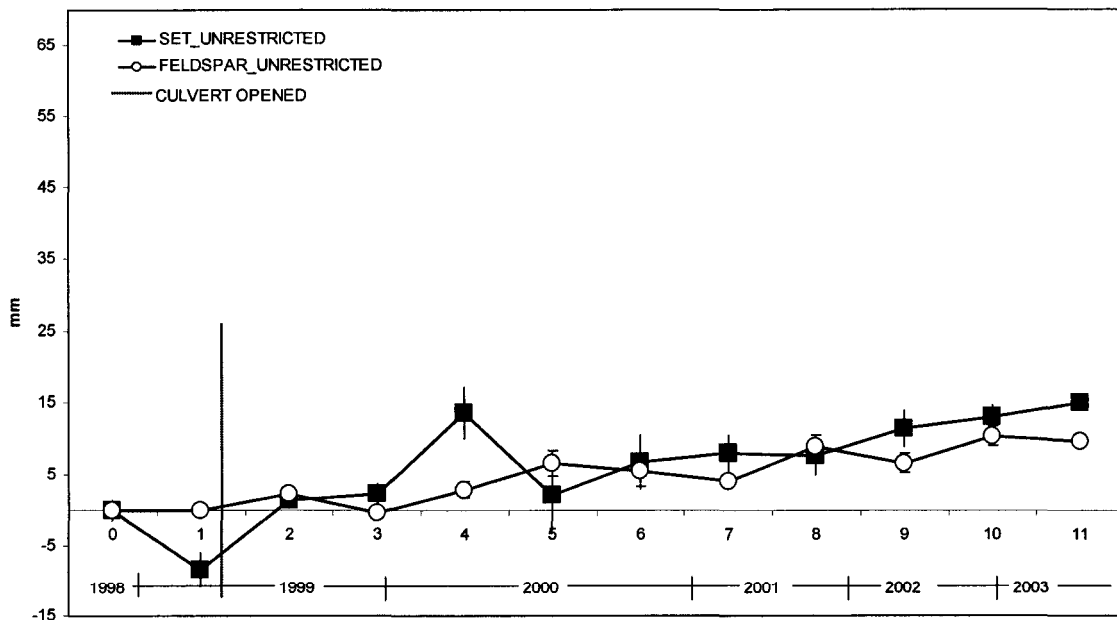
**Figure 3.21: Trends in sedimentation as measured by sediment elevation tables (SETs) and feldspar horizons at Hatches Harbor in the unrestricted marsh below the dike. This shows a small increase in sediment deposited within the marsh, commensurate with sea-level rise. (Portnoy et al., 2004)**

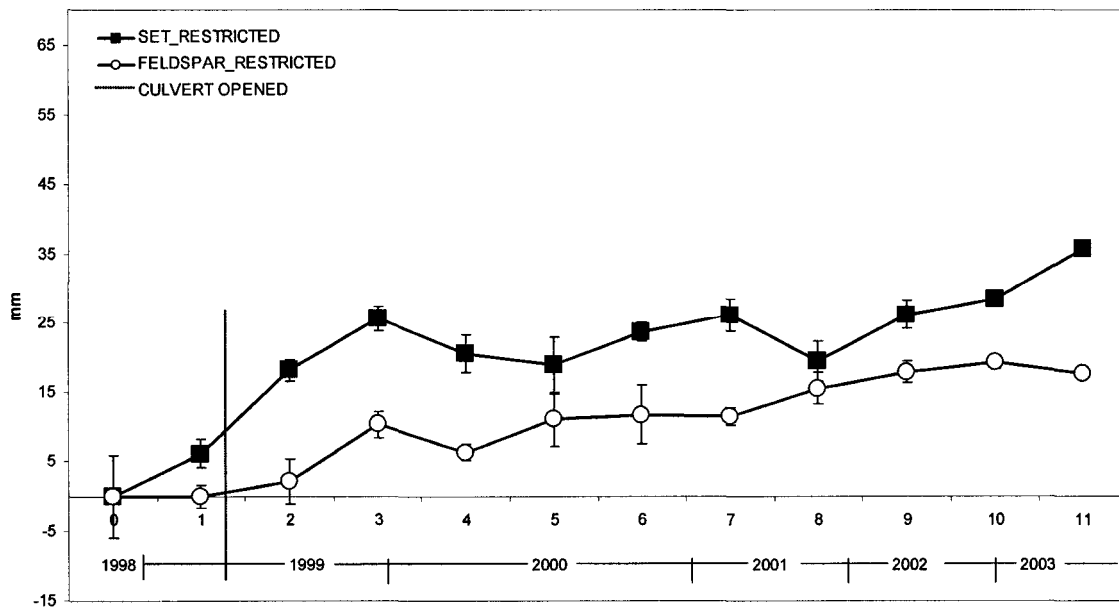
**Figure 3.22: Trends in sedimentation as measured by sediment elevation tables (SETs) and feldspar horizons at Hatches Harbor in the restricted marsh above the dike. With tidal restoration, sedimentation above the dike has exceeded that measured in the unrestricted marsh downstream (Portnoy et al., 2004).**

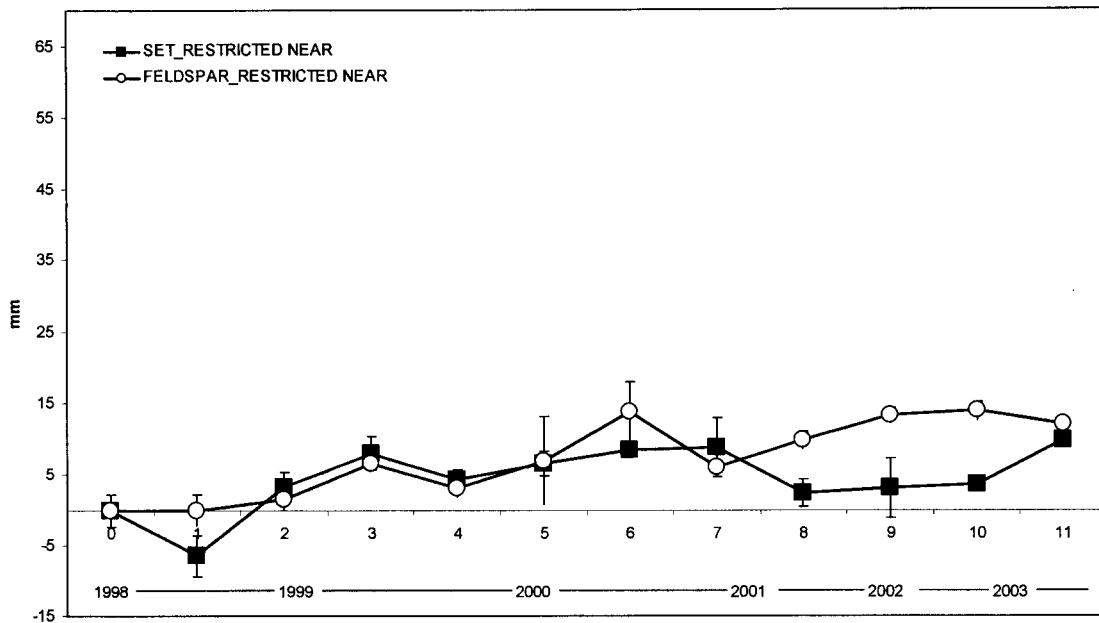
**Figure 3.23: Trends in sedimentation as measured by sediment elevation tables (SETs) and feldspar horizons in the Hatches Harbor restricted marsh directly above the dike. These data show that accumulation rates just above the dike are similar to those just below. (Portnoy et al., 2004)**

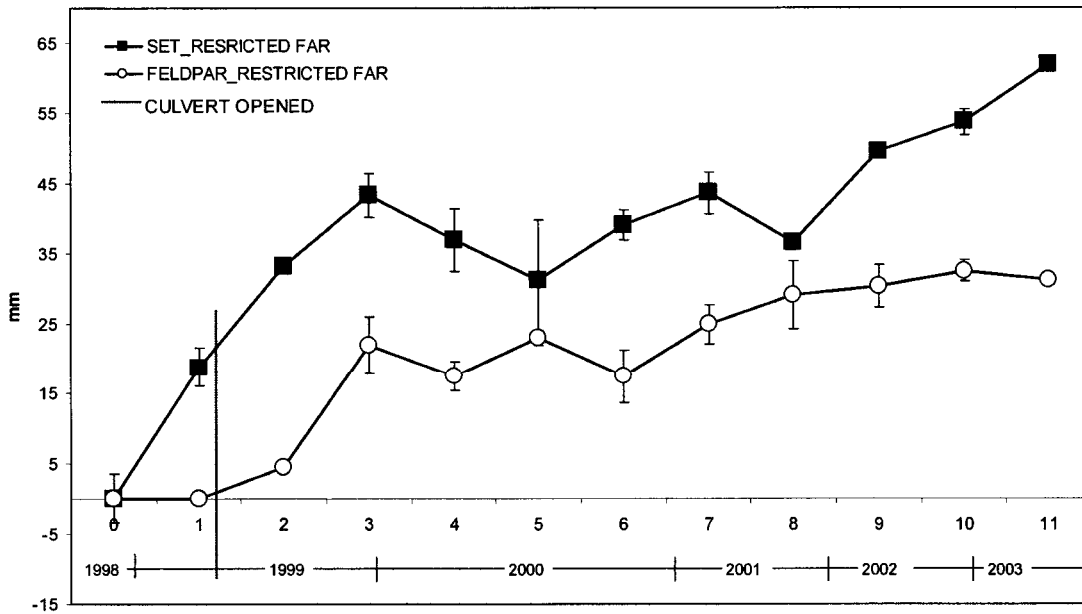
**Figure 3.24: Trends in sedimentation as measured by sediment elevation tables (SETs) and feldspar horizons in the Hatches Harbor in the restricted marsh farther upstream of the dike. These data show that the majority of the sediment is being deposited farther upstream from the dike. (Portnoy et al., 2004)**

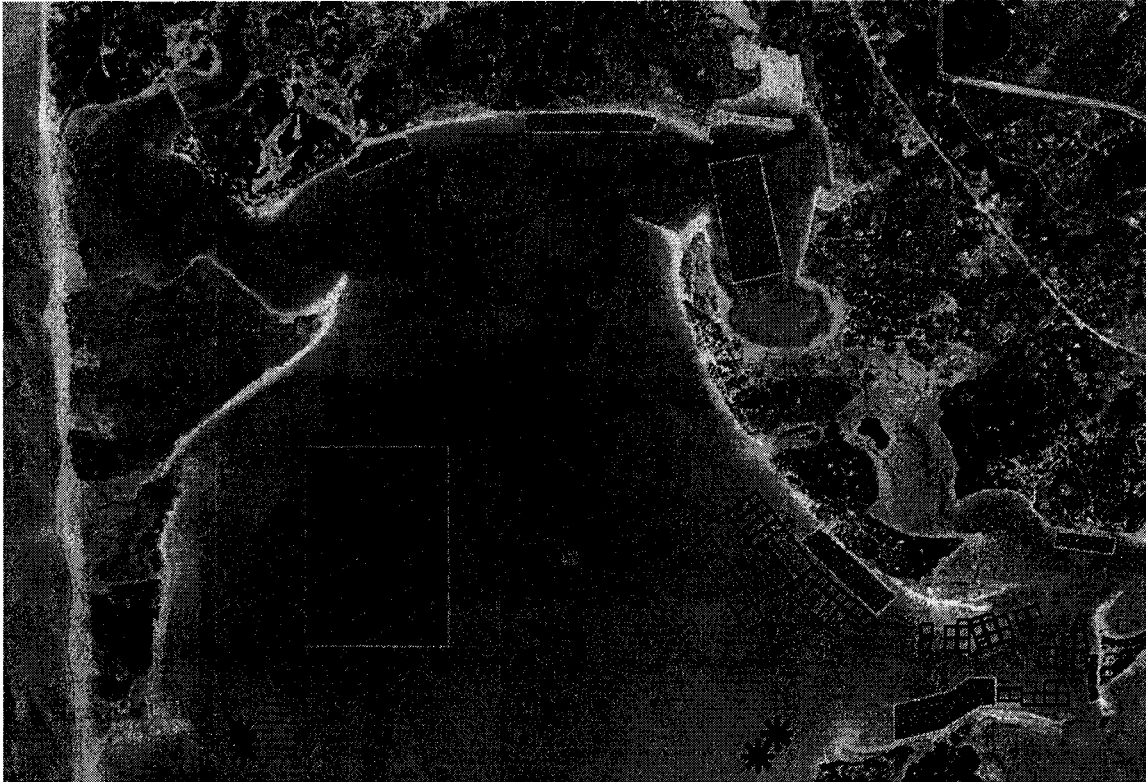
**Figure 3.25: Enlarged version of hard structure map (Figure 3.16), focusing on the location of shellfish grants.**
