Post Restoration Monitoring and Evaluation, Sesuit Creek: FINAL REPORT

Gregg E. Moore and David M. Burdick

University of New Hampshire

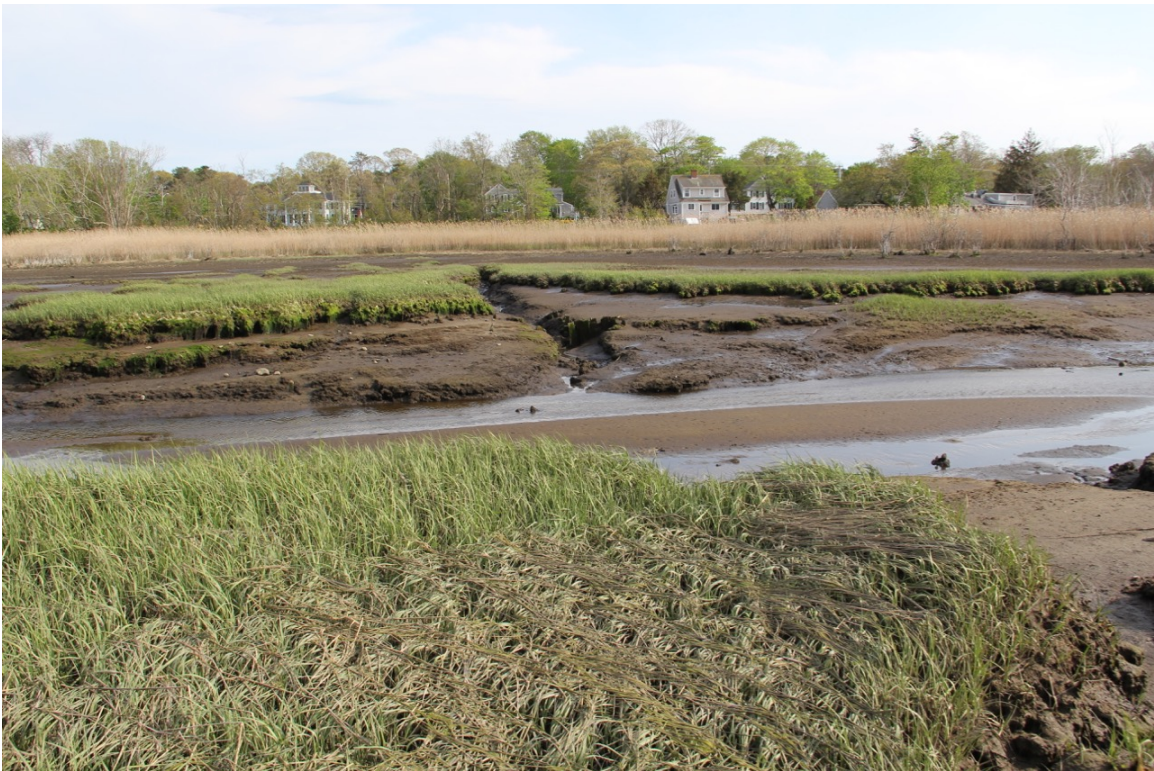
Figure 1: Overview of restoration area showing native marsh, bare mud flats, and Phragmites-dominated areas. Even at this scale, the lower elevation portions of the restoration area are visibly noticeable.

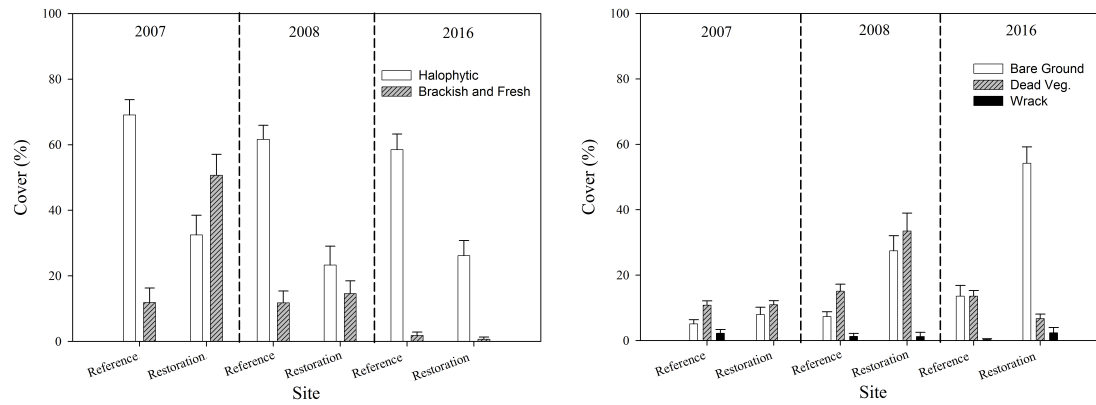
Figures 3 and 4: Comparison of percent cover for halophytes vs brackish-fresh species by observation year (left) and the change in unvegetated area over same time period (right).

In terms of overall plant community response, evidence of change can be interpreted several ways. Since a central goal of the restoration work was to deter *Phragmites* (a brackish-fresh species), the vegetation data support the achievement of this goal (Figure 3). Percent cover of brackish-fresh species declined dramatically in the restoration site over time and that decrease was statistically significant from year to year. However, the percent cover of halophytes, while variable, did not change significantly over the same period. This trend is immediately obvious in the field and is associated with the rise of barren, often eroded mudflat areas (Figure 4). It appears that halophytes have not recolonized formerly brackish-fresh dominated areas of the marsh, despite evidence that pore water conditions have developed to now support halophytic communities (Section 2.3). The factors that likely influence this pattern are discussed in detail in Section 4.0.

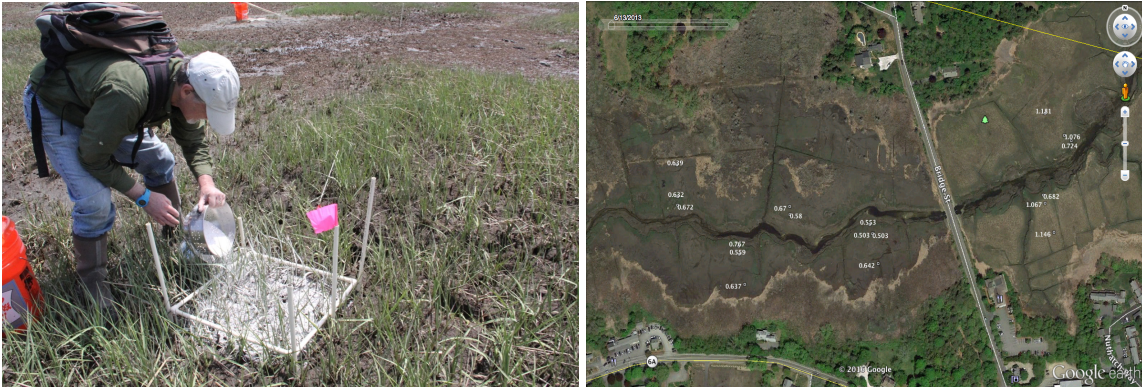
3.1 In mid-May 2016, our Team established marker horizons to evaluate marsh accretion in the restored marsh area (Figure 9). We established three feldspar marker horizons (comprising three replicates each) along a linear gradient from creek to upland within both the restoration and reference areas (18 markers total) using the protocol defined by Lynch et al. (2015). Each marker horizon measured 0.25 m² with corners marked by PVC pipe. The creek edge horizons were situated ~5 m from the main tidal creek. The additional horizons were situated at ~10 and 50m distances landward of the creek. Each marker horizon was survey located in the field (see Task 4).

Figure 9. Establishing feldspar marker horizons in restoration and reference marsh areas (left) and; location of feldspar marker horizons with elevations shown in meters (right). Note that ALL the restoration plots are well under 1m in elevation at the marsh surface, while only low marsh/creek bank plots in the reference marsh follow this pattern. Essentially, the entire restoration area appears to exist at a 'low marsh' elevation – and thus its plant community should reflect that condition.

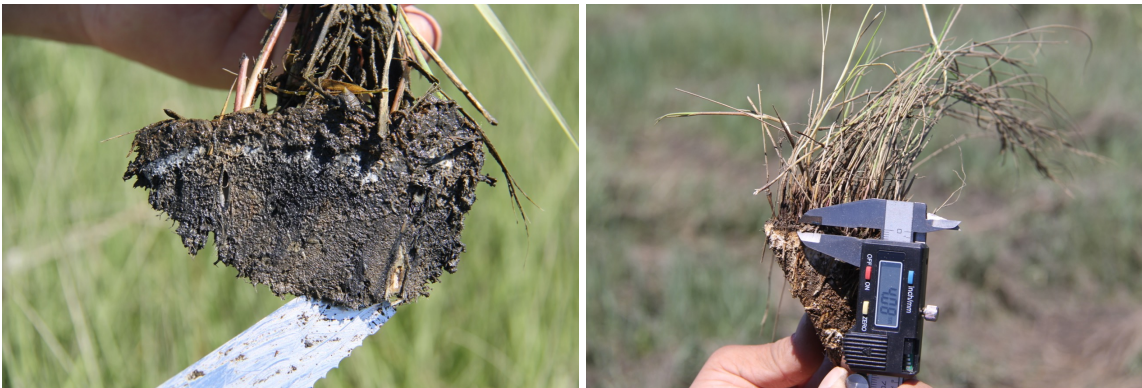
quantify fine-scale accretion using a micrometer (Figure 10). Accretion rates varied widely, but in general, there was a linear relationship between accretion and distance from the main creek. The greatest accumulation of sediment was found in the plots closest to the creek, and the least amount of accretion occurred in unvegetated areas. In the three cases where the feldspar layer was not found, it was not possible to accurately determine whether the feldspar was washed away, or if the area was subject to erosion (taking feldspar and underlying layers of sediment). It should be noted each of these three cases each occurred in unvegetated mudflats within the restoration area. Accretion was clearly documented in 100% of the reference marsh plots regardless of distance from the creek.

Figure 10. Examples of sediment accretion in low marsh creek bank (left) and high marsh (right) marker horizon plots.

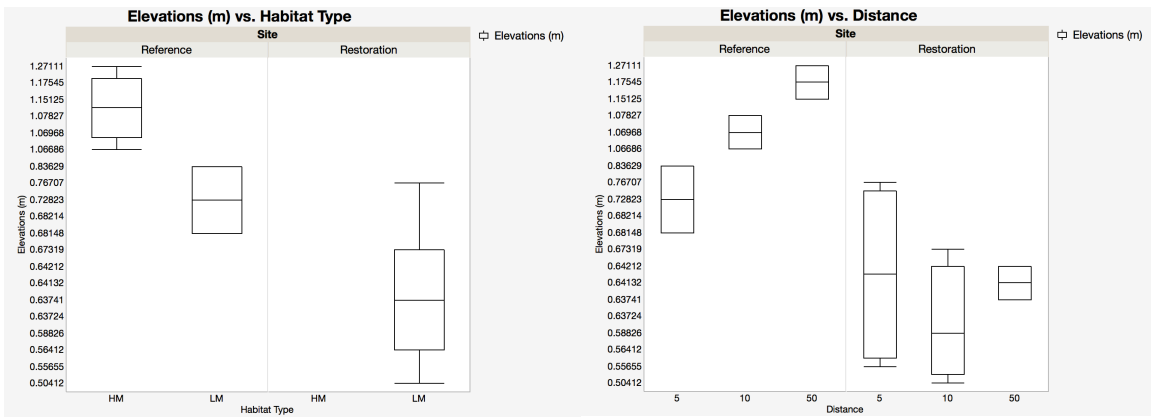
The RTK data show that the restoration area is significantly lower in elevation (~0.25m) than the reference site overall. In fact, all the elevation plots in the reference area are under 1m NDVG. The break point between high and low marsh hovers just under the 1m elevation mark in the reference marsh. This finding is particularly evident in the sediment accretion plots (Figure 13-14) as further inspection of the data reveal that the bare, mudflat areas of the restoration area contribute significantly to these low elevations. In addition, we noted 22 of the ~130 vegetation plots occur in bare, mudflat areas in the restoration marsh with a mean elevation of 0.86m, well below the mean of vegetated plots in the reference. In contrast, the *vegetated* low marsh habitat elevations vary little between the reference and restoration areas. That said, we noted that one expected species in particular was absent from the restoration area. Slender grasswort (*Salicornia depressa*) was only noted in the reference marsh, occurring in varying density in roughly 30% of all plots.

Figures 13-14. Elevation of sediment accretion plots for reference and restoration marsh areas grouped by distance from creek edge (left) and by habitat type (right).

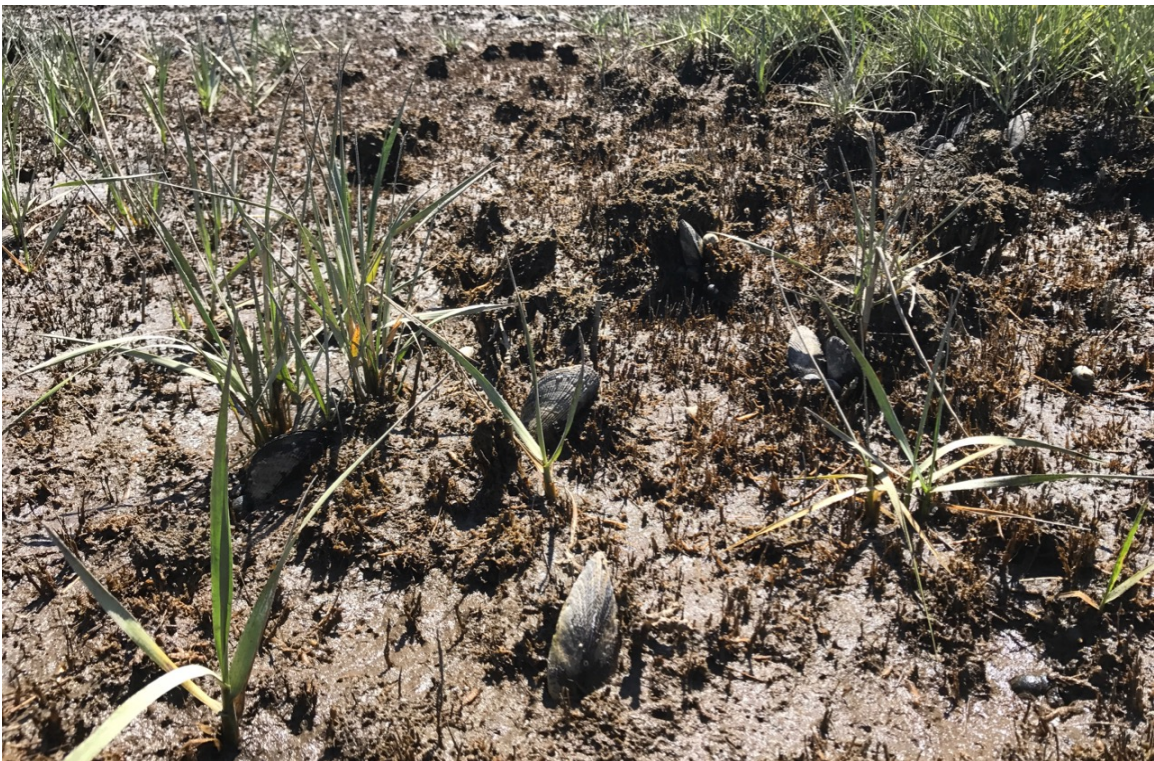
Figure 15. Example of a low marsh area in the restoration site showing evidence of rapid erosion – soon to become mudflat?

In the reference marsh, measured plot elevation follows a linear gradient, increasing as one moves landward from the creek edge. Arguably, this is not the case in the restoration area. Plots located 10m from the creek are lower in elevation than the plots located 5m and 50m from the creek edge. This distinction plays an important role in understanding why major portions of the restoration area remain unvegetated. There is some evidence these areas are eroding, such as exposed roots and rhizomes (Figure 15), acting as a source rather than a sink for sediment. But portions of these low marsh-mudflat areas in the restoration area are also consistently flooded by relatively deep water (20-40 cm) on daily tides and portions remain saturated at the sediment surface even during low tide periods. It is possible that some of these areas are too low in elevation to naturally recruit propagules or seeds that may be present in the system are not experiencing suitable condition to germinate under present conditions. Although we feel confident that the majority of the bare areas may be encouraged to colonize through direct planting of bare root seedlings or plugs since pore water conditions are not unfavorable for establishment. Finding those suitable locations may be as simple as using the RTK or Lidar to define the elevations that correspond with dense native low marsh communities in the adjacent reference – but planting lower elevations may still be of value given the dire need to stabilize these soft, eroding sediments.

The data collected in this study suggest that despite the successful removal of common reed (*Phragmites australis*), the site remains impacted and may require additional management actions to fully realize restoration goals. Low areas in the restoration area are slow to recolonize with native vegetation despite having suitable pore water chemistry overall. RTK-based elevation surveys support the obvious fact that this restoration site is significantly lower in elevation than the adjacent reference marsh and significantly less vegetated. Meanwhile, our sediment accretion study demonstrated significant accretion in all vegetated sampling plots, whether in the reference or restoration portions of the site. Accordingly, the barren, mudflat areas within the restoration area are acting as a source, rather than a sink for sediment and must be addressed to slow the rate of sediment loss and erosion.
