2022 Site Report for Eastern Box Turtles Herring River Restoration Project

**Turtle Protection Plan
Herring River Restoration Project
Wellfleet, MA**

**MA Natural Heritage & Endangered Species Program
NHESP File #04-15126**

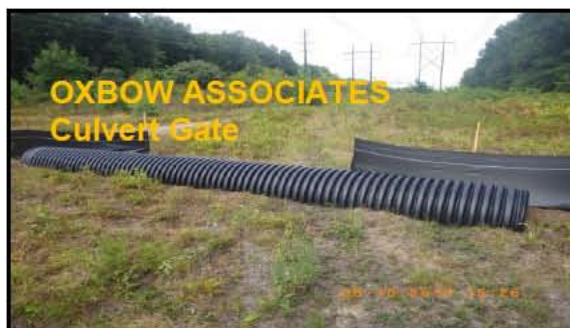
PVC Culvert "Gate"

within areas specified by the NHESP. Installation of the barrier using a Ditch-Witch and chain saws will allow the barrier to be installed with very low probability of injuring or killing individual animals. Any other methods using larger machinery must be approved by the NHESP. Moveable gates made with corrugated PVC 18-inch or larger, half culverts, or wooden gates may be required at the construction access locations (See Photos).

The area will have a turtle barrier installed. The Contractor plans to use a ditch-witch and hand tools only to install the fencing, and will use either a wooden or PVC gate at the entrance to the staging area on Duck Harbor Road, and at a personnel entrance on the perimeter closes to the river. Vegetation will be cut flush to the ground and the Contractor proposes to relocate up to 1,850 cubic yards of material from the Town Pit borrow site on Pole Dike Road (see below) for placement as base material at the Duck Harbor Road staging area.
